## **Testimony to an A300B4 and his crew**

DHL International Aviation,  
Bahrain.

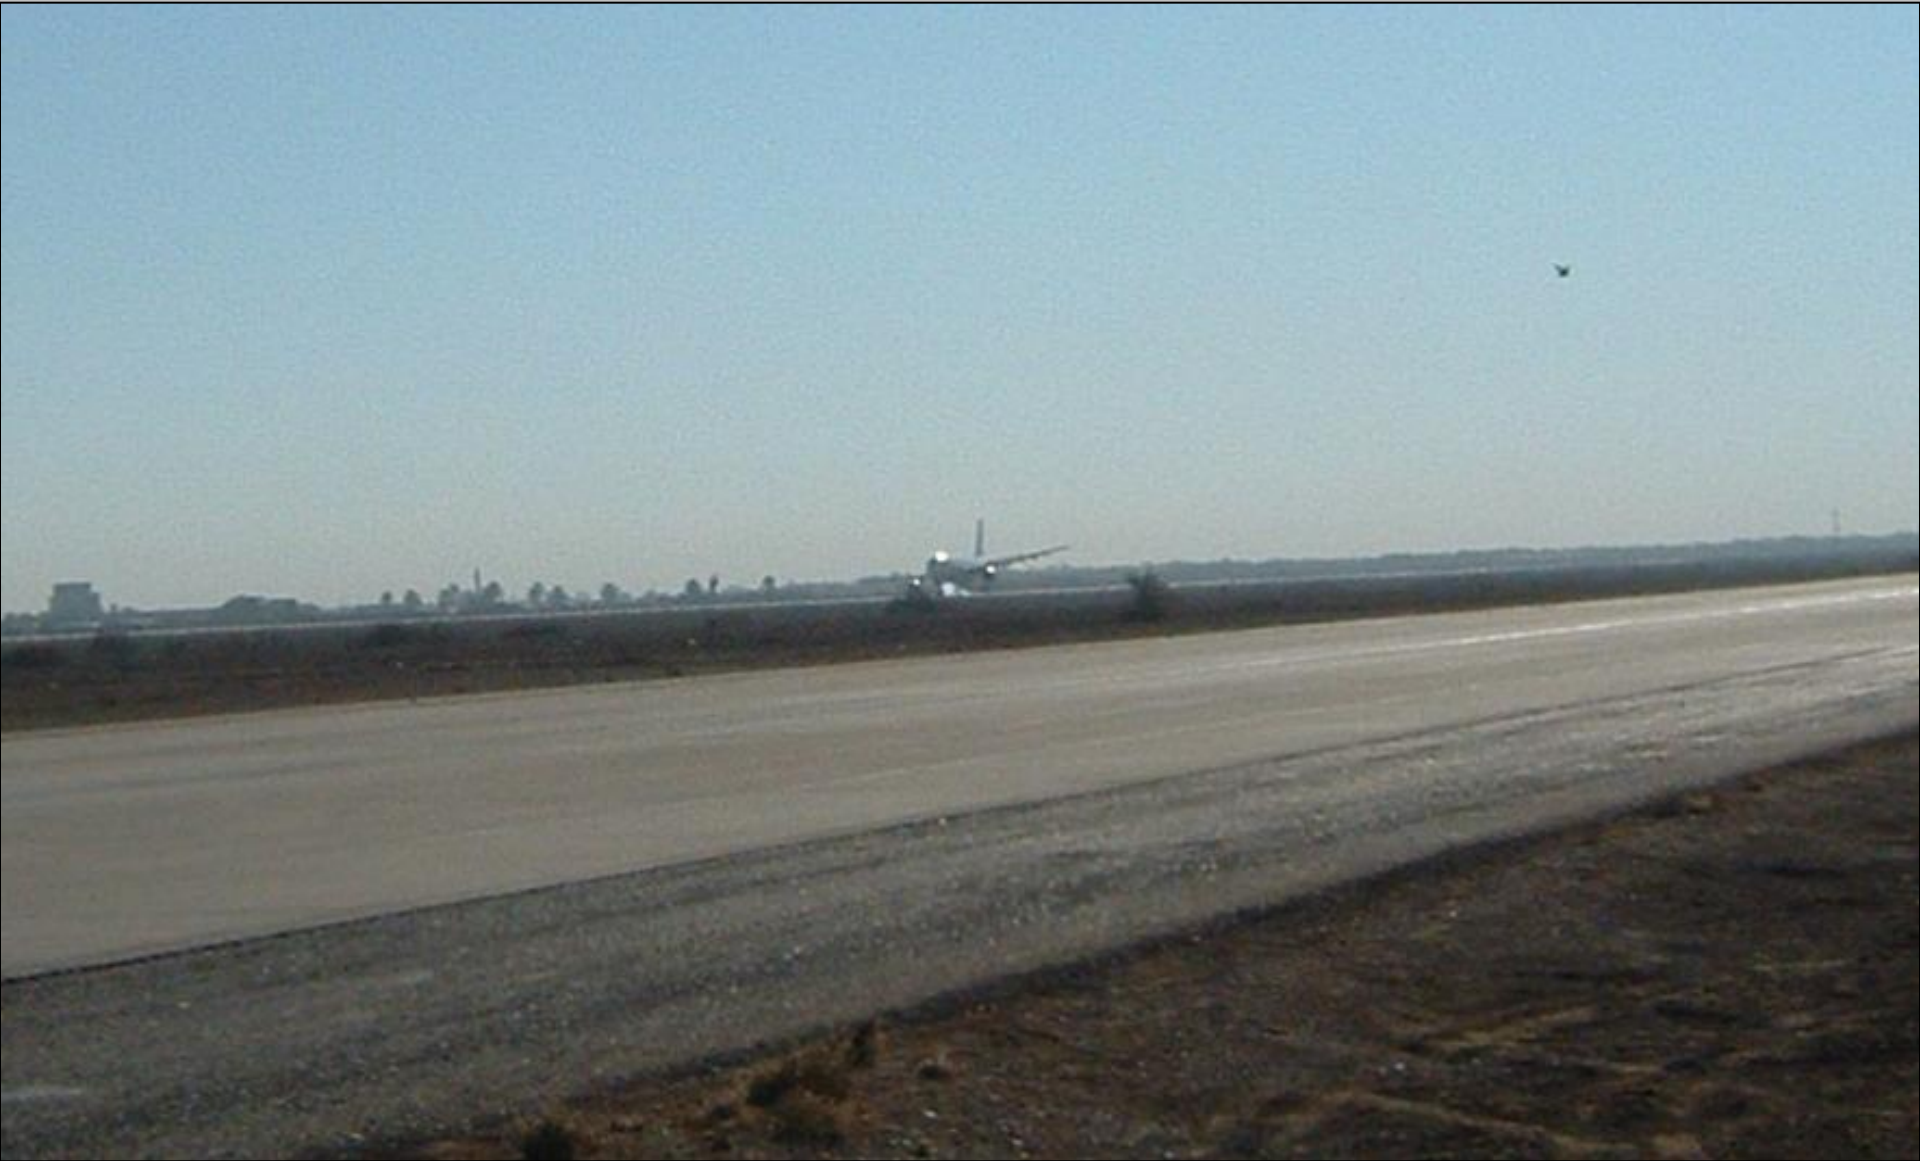
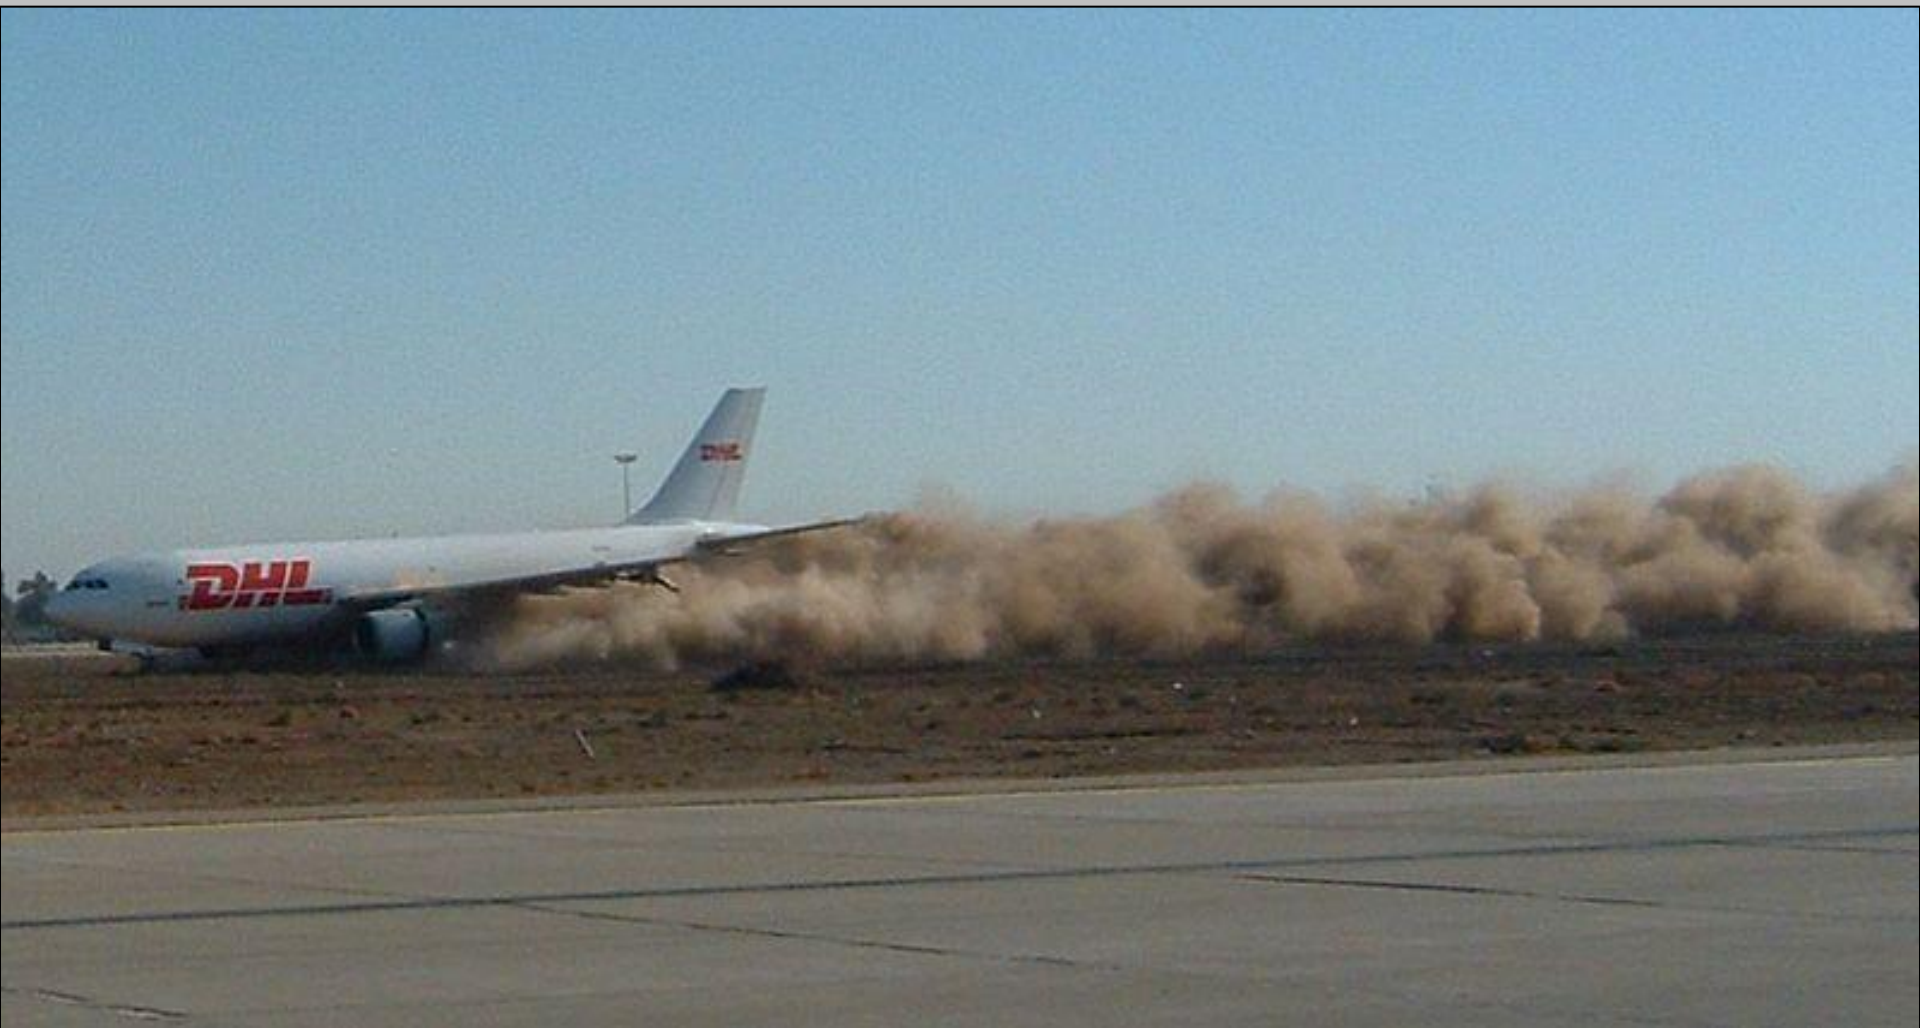
To those of you who are wondering what happened to the DHL A300B4 coming out of Baghdad last Saturday, take a look. Aircraft was hit at 8000 FT, lost ALL hydraulics and therefore had no flight controls, actually did a missed approach using only engine thrust and eventually (after about 16mins) landed heavily on runway 33L at Baghdad. This was fortunate because with no steering the aircraft veered off the runway to the left, had they landed on 33R veering to the left would have taken them straight into the fire station.

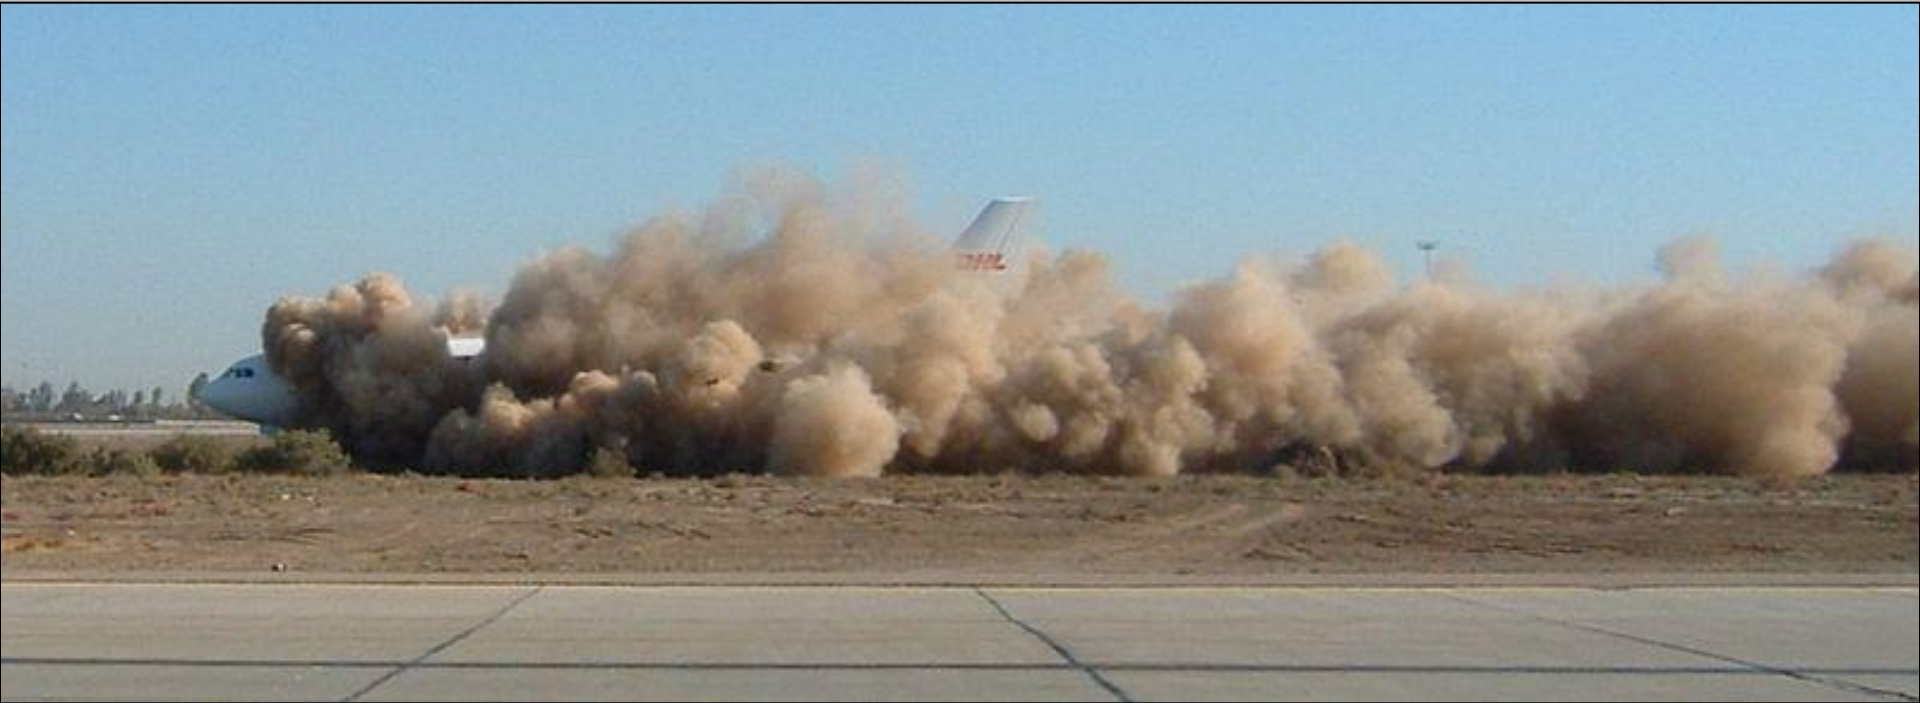
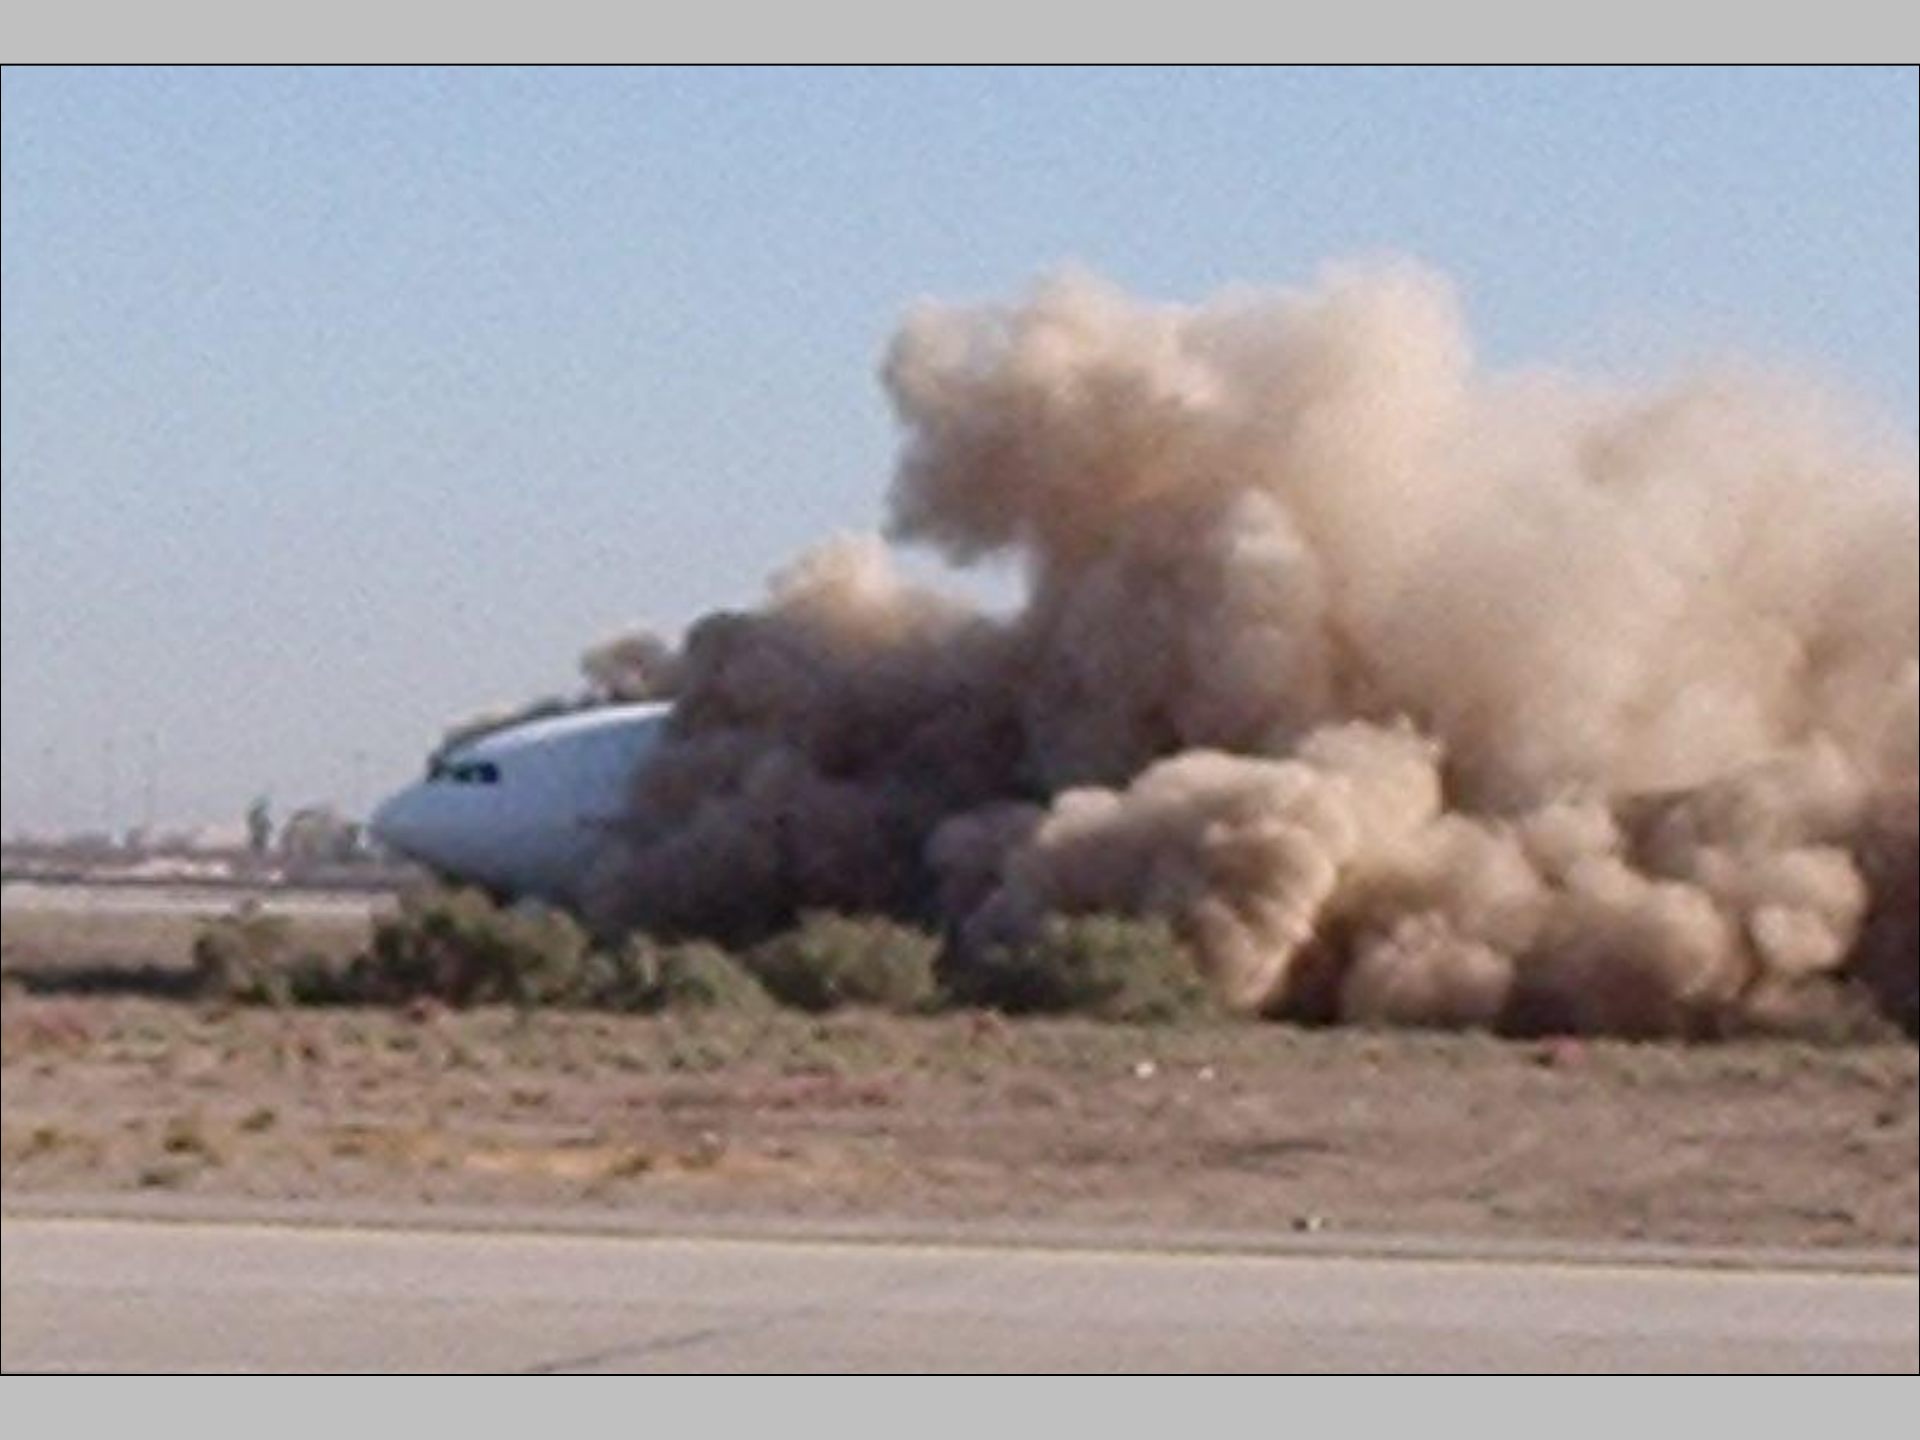
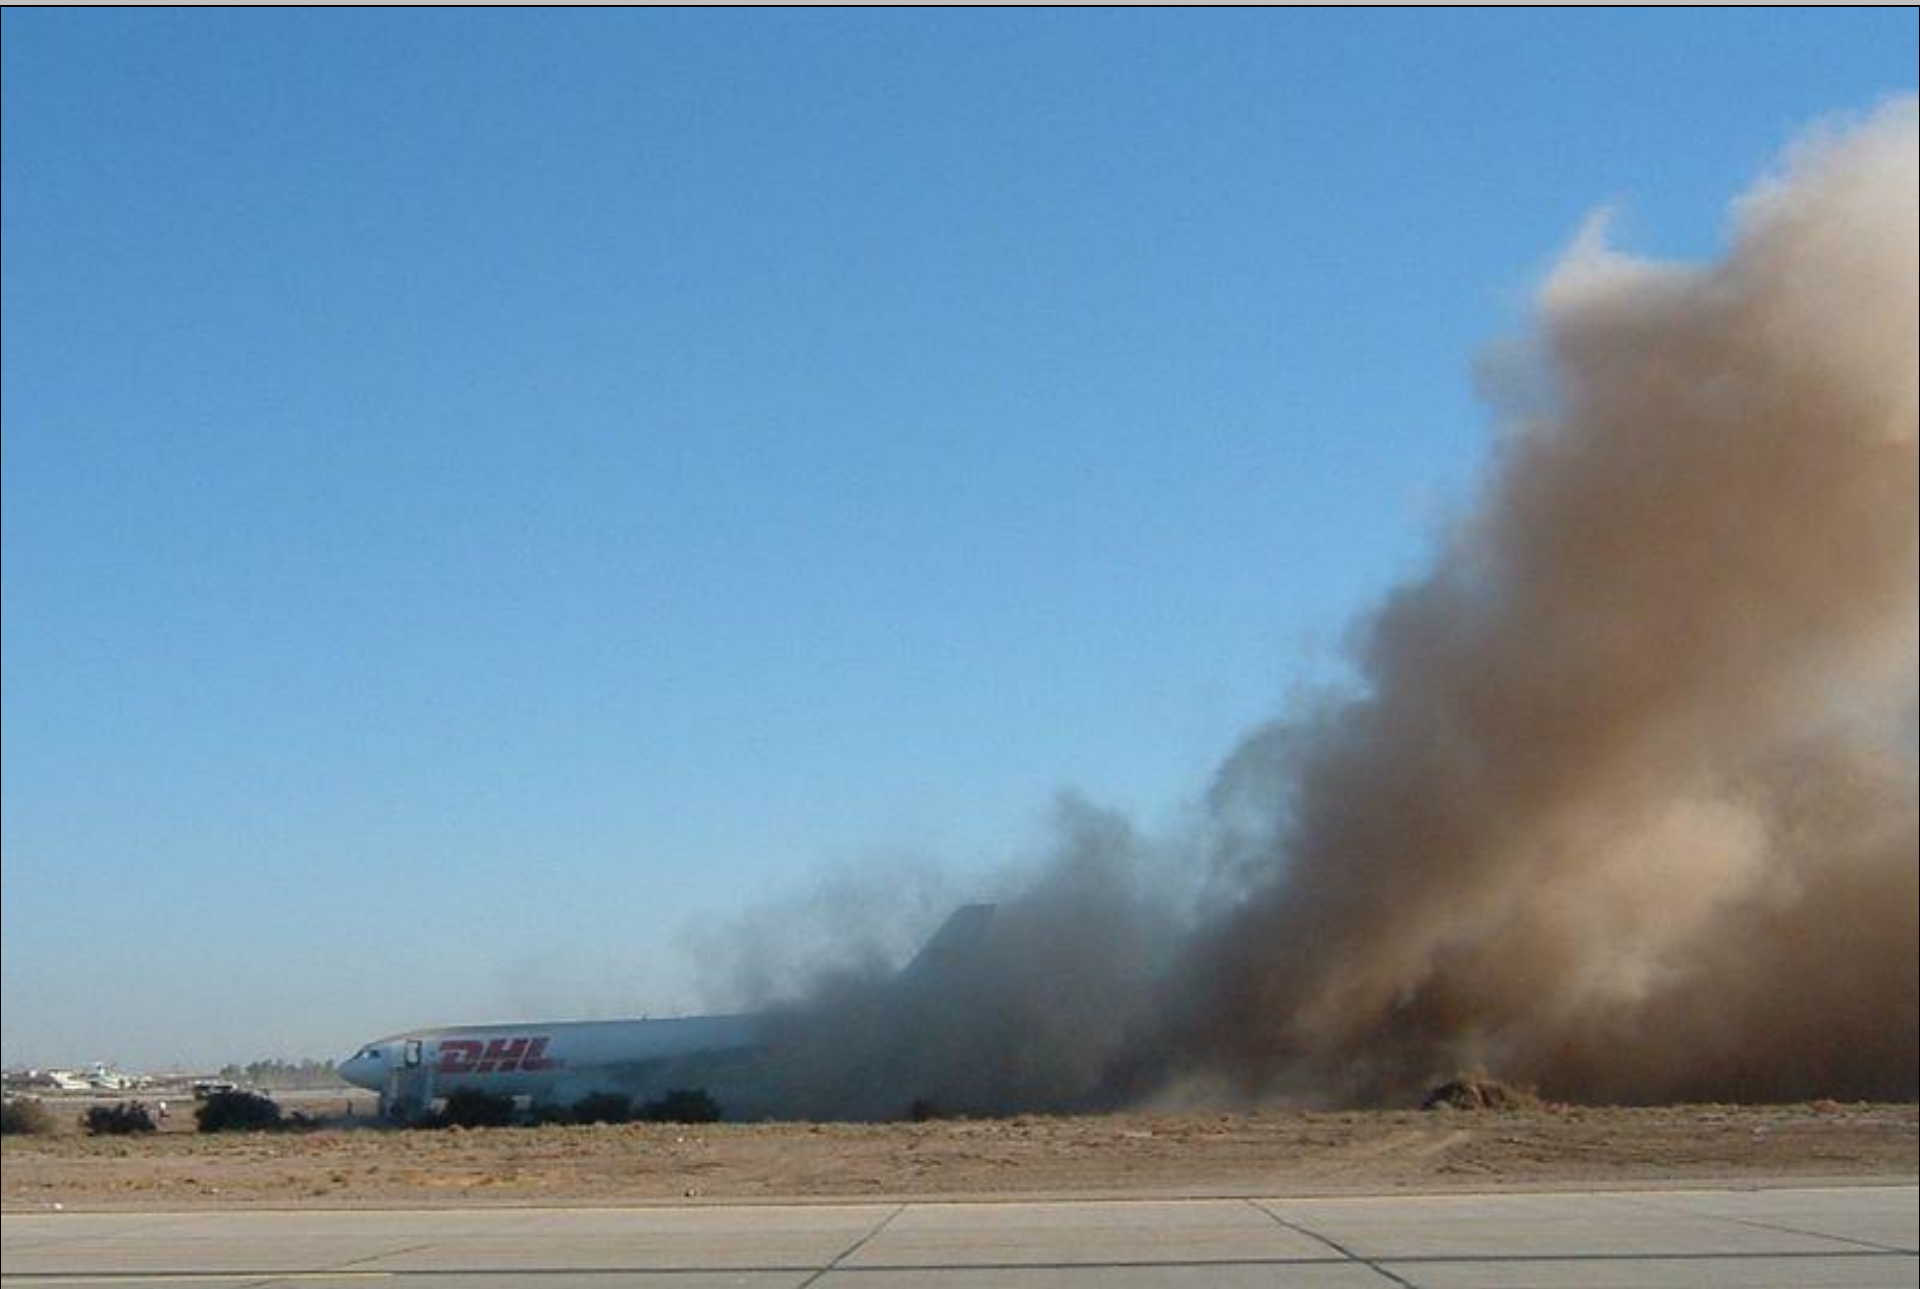
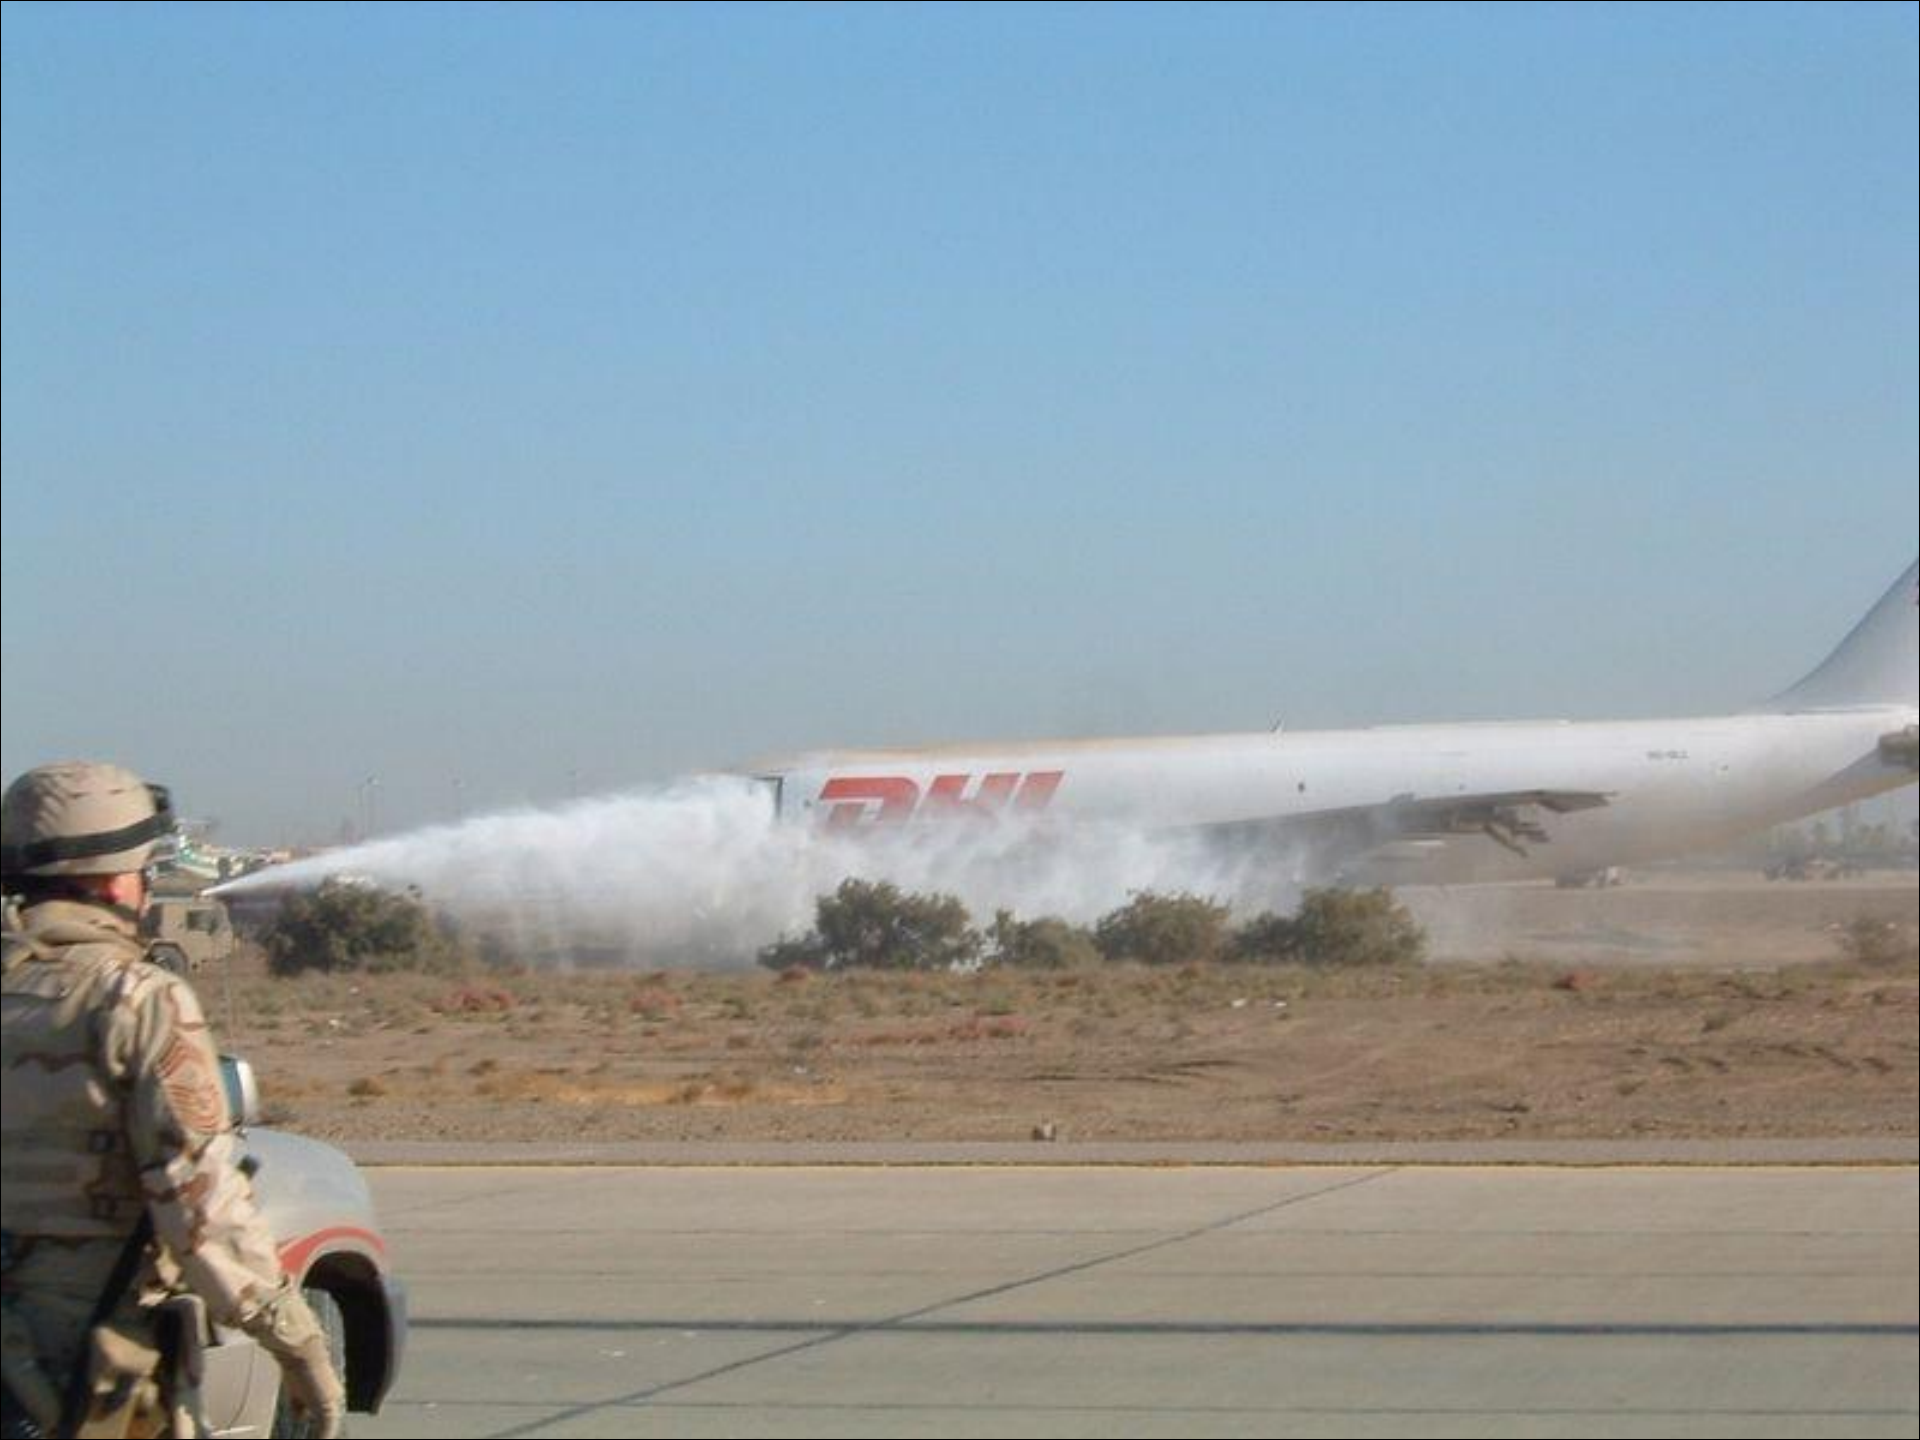
The aircraft then travelled about 600 metres through soft sand taking out a razor wire fence in the process, see LH engine pic, and came to rest almost at the bottom of the sloping area between the runway and a taxiway.

All three crew evacuated safely down the second slide, the first one tore on the razor wire.

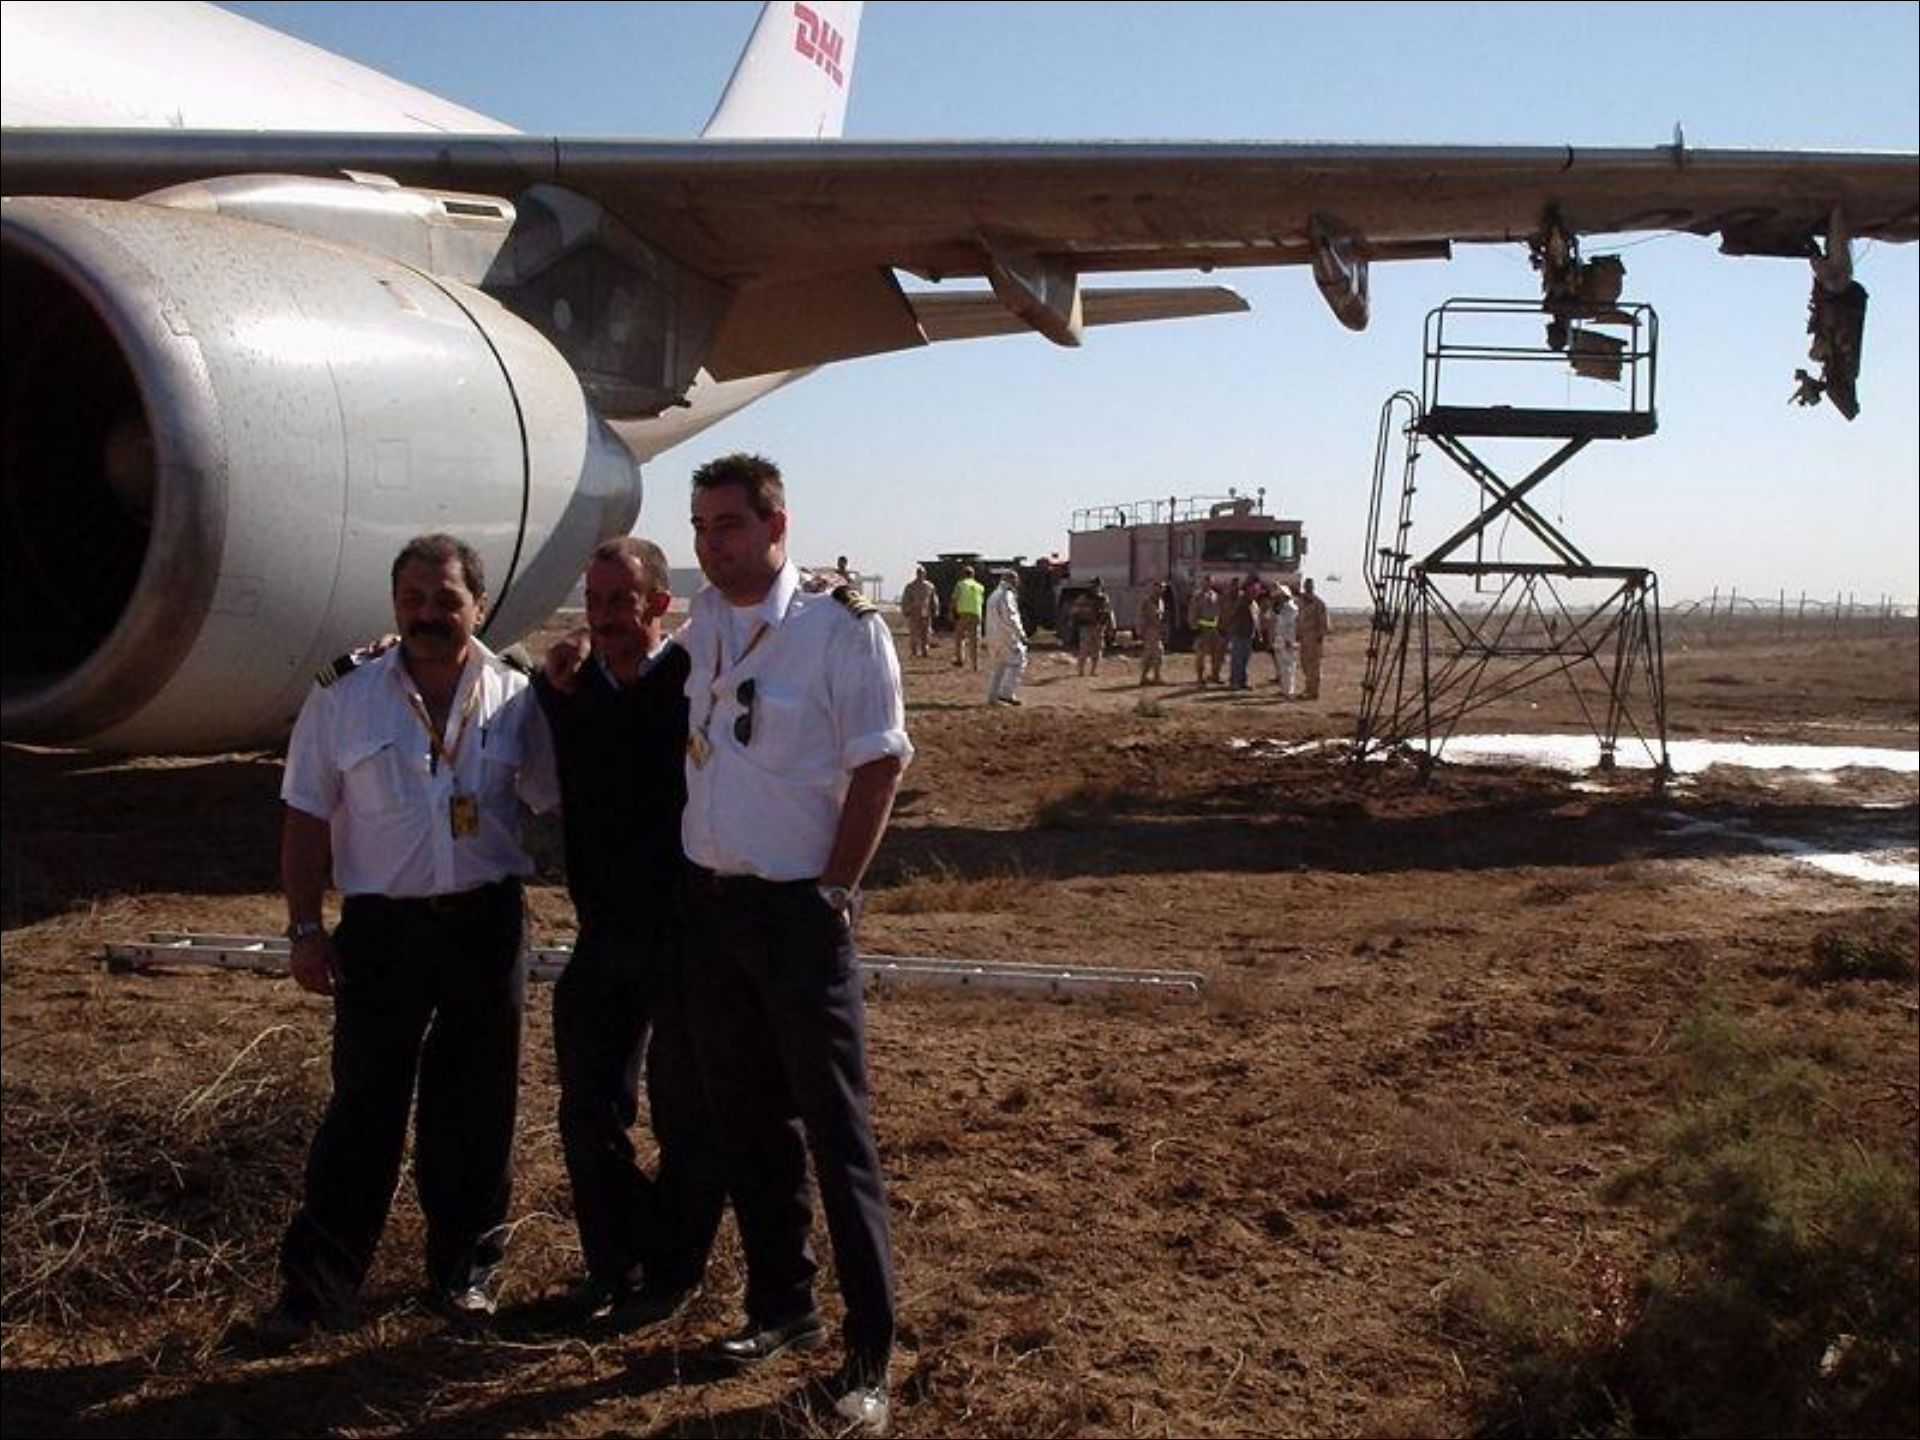
I flew in with a team on Tuesday in one of our Metros and some special equipment we'd had made locally in Bahrain and some provided by Airbus. Using a USAF D9 Caterpillar pulling a 100 metre cable fitted to the back end of each bogie and a nice new aircraft pushback tug with a towbar on the nose gear, we were able to remove the aircraft just on dusk on Tuesday night and towed it to an Iraqi Airways graveyard on one side of the terminal. We stayed overnight in the USAF camp on the airport and went back to the aircraft on Wednesday morning to allow the insurance survey to be completed and then secure the aircraft. Basically, LH engine rotates in a fashion, has ingested lots of razor wire and is knackered. RH engine has seized, probably from ingesting loads of sand at maximum reverse thrust and inlet cowl has unacceptable lip damage, probably from hitting the razor wire fence posts.
