## **Testimony to an A300B4 and his crew**

DHL International Aviation,  
Bahrain.

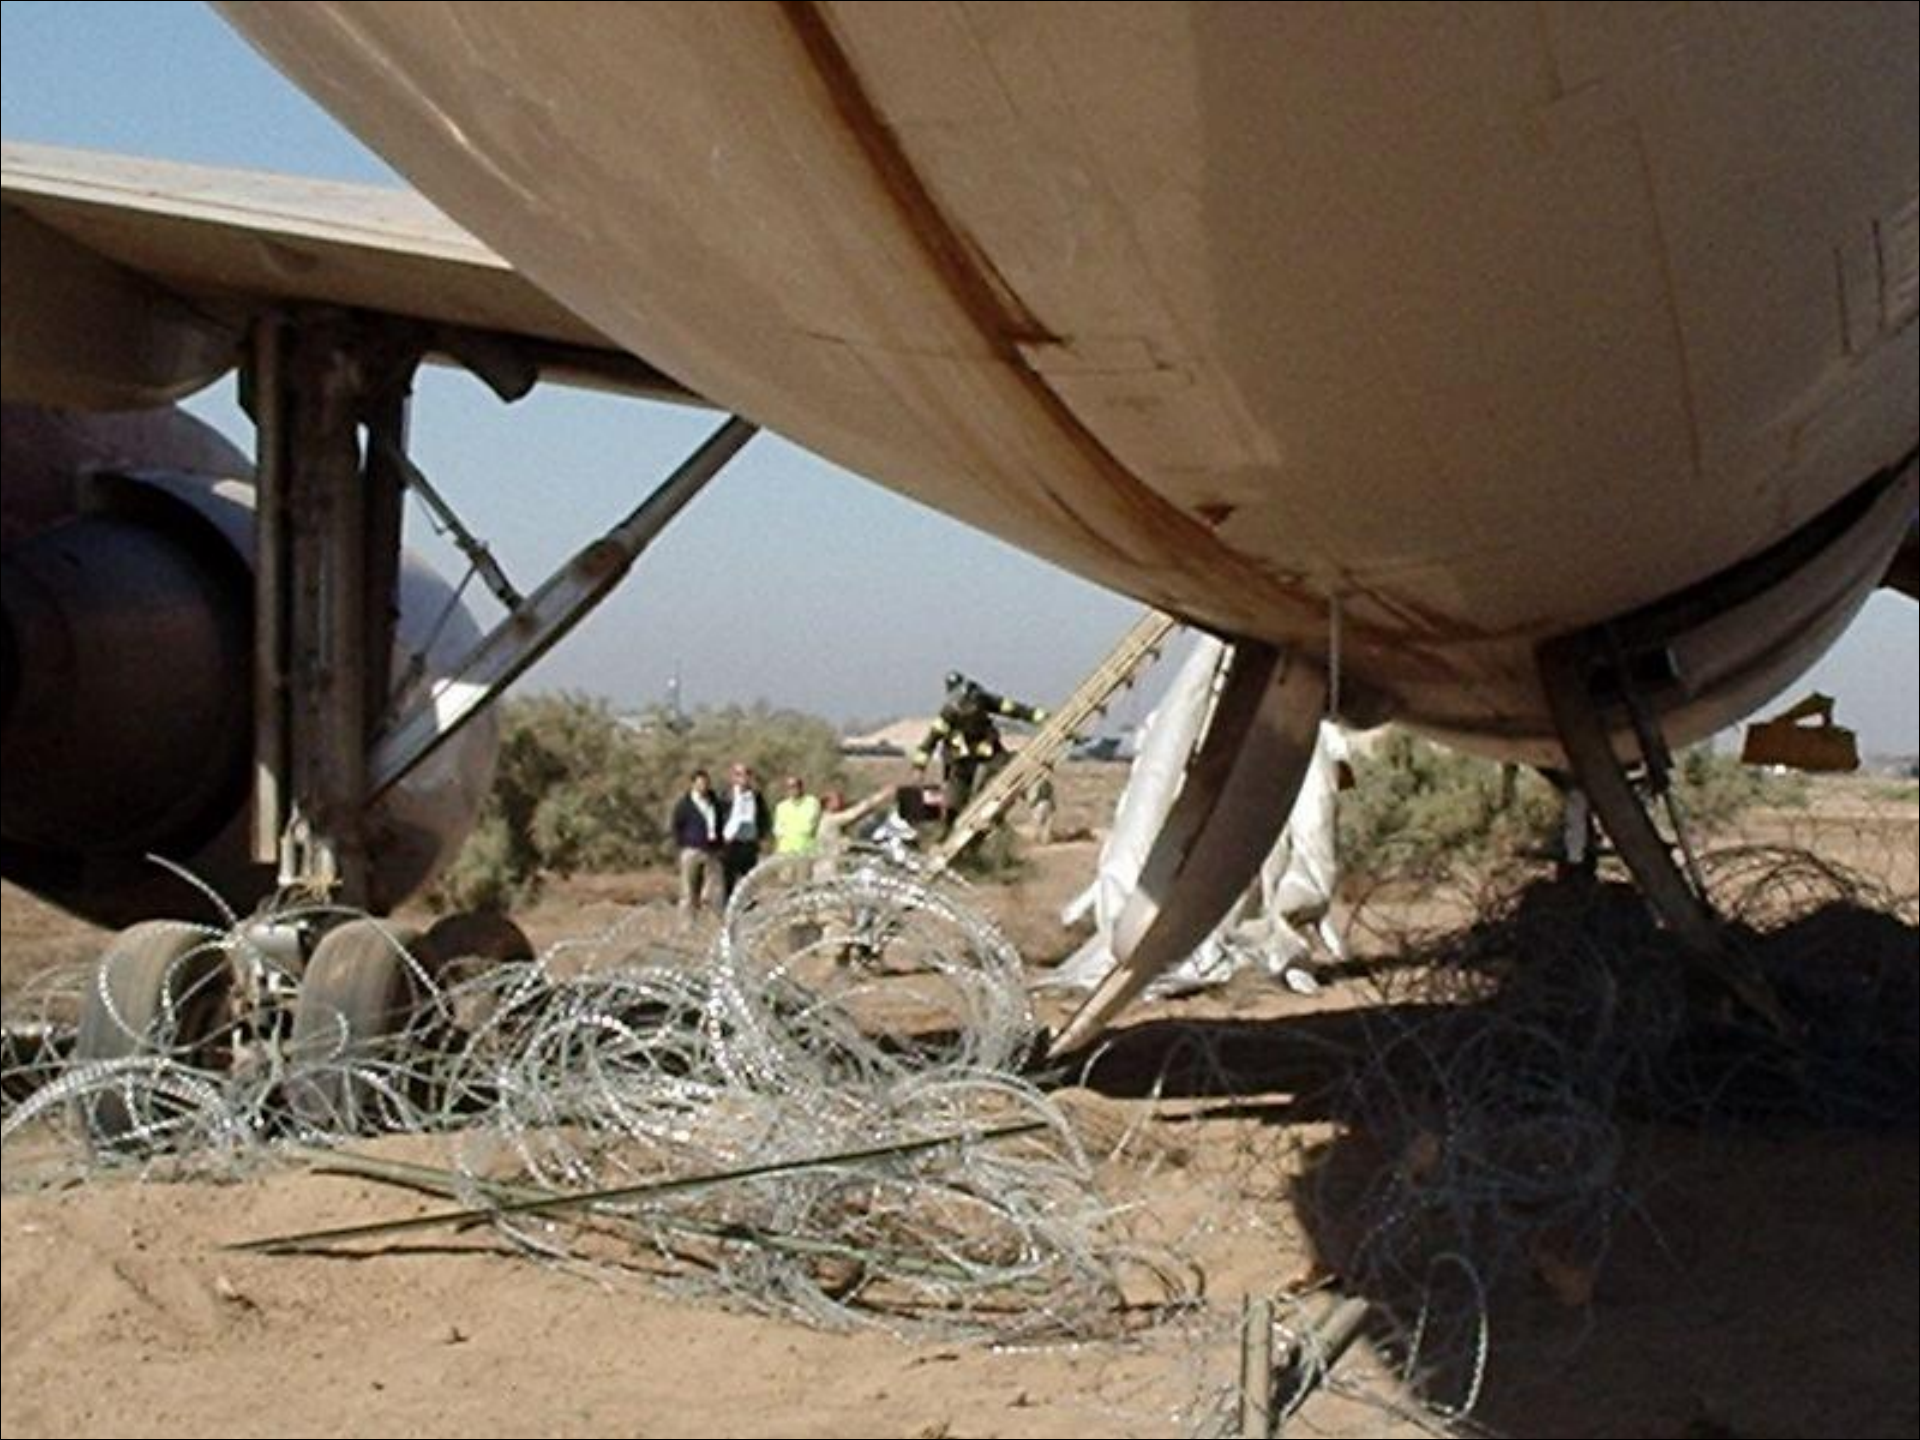
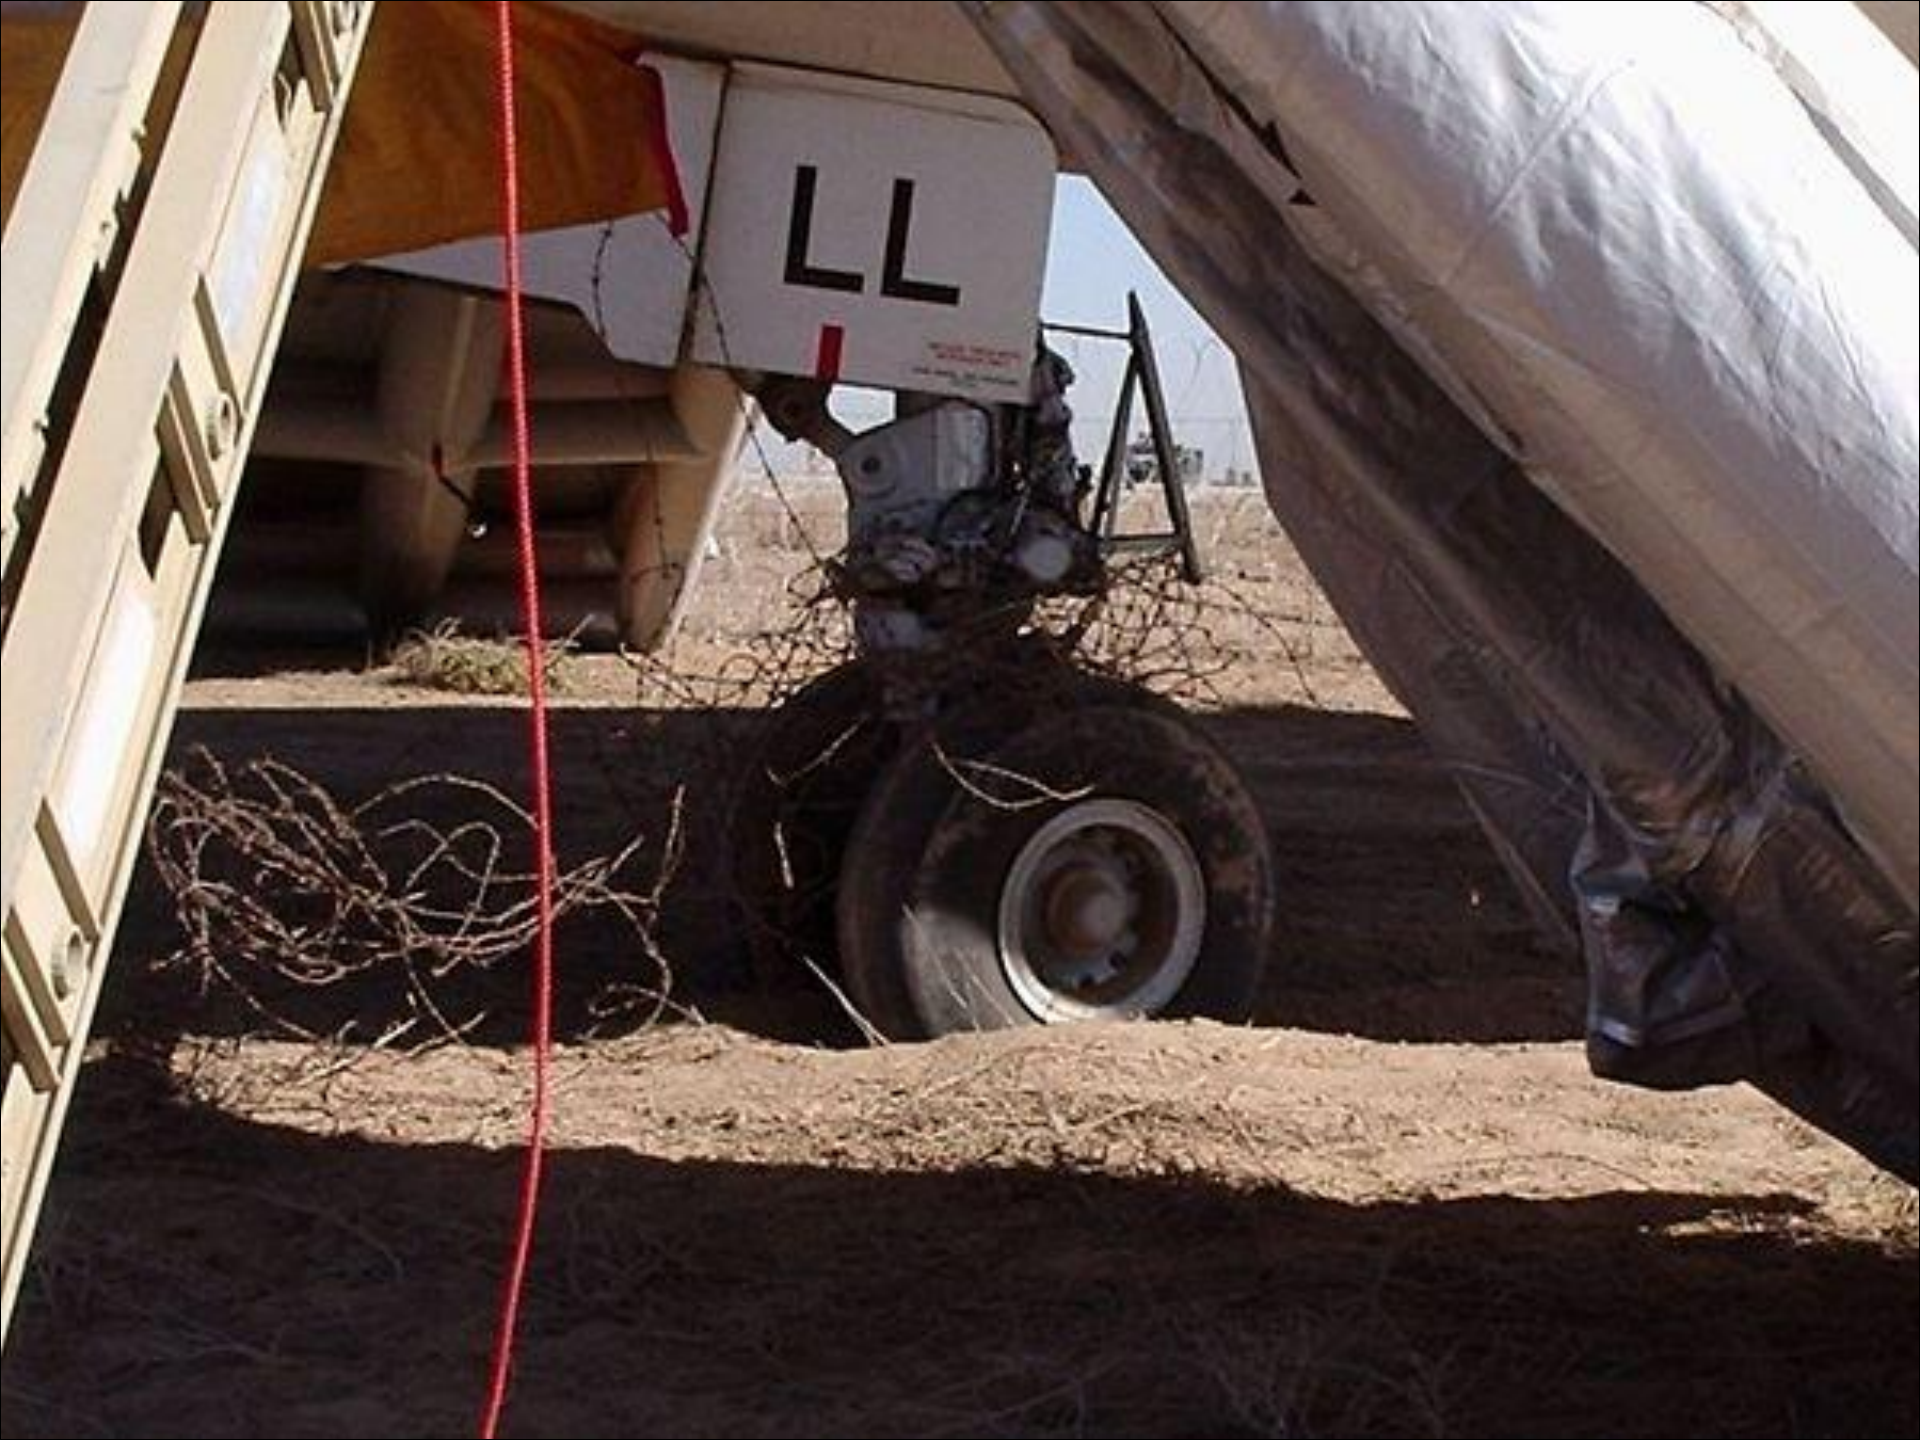
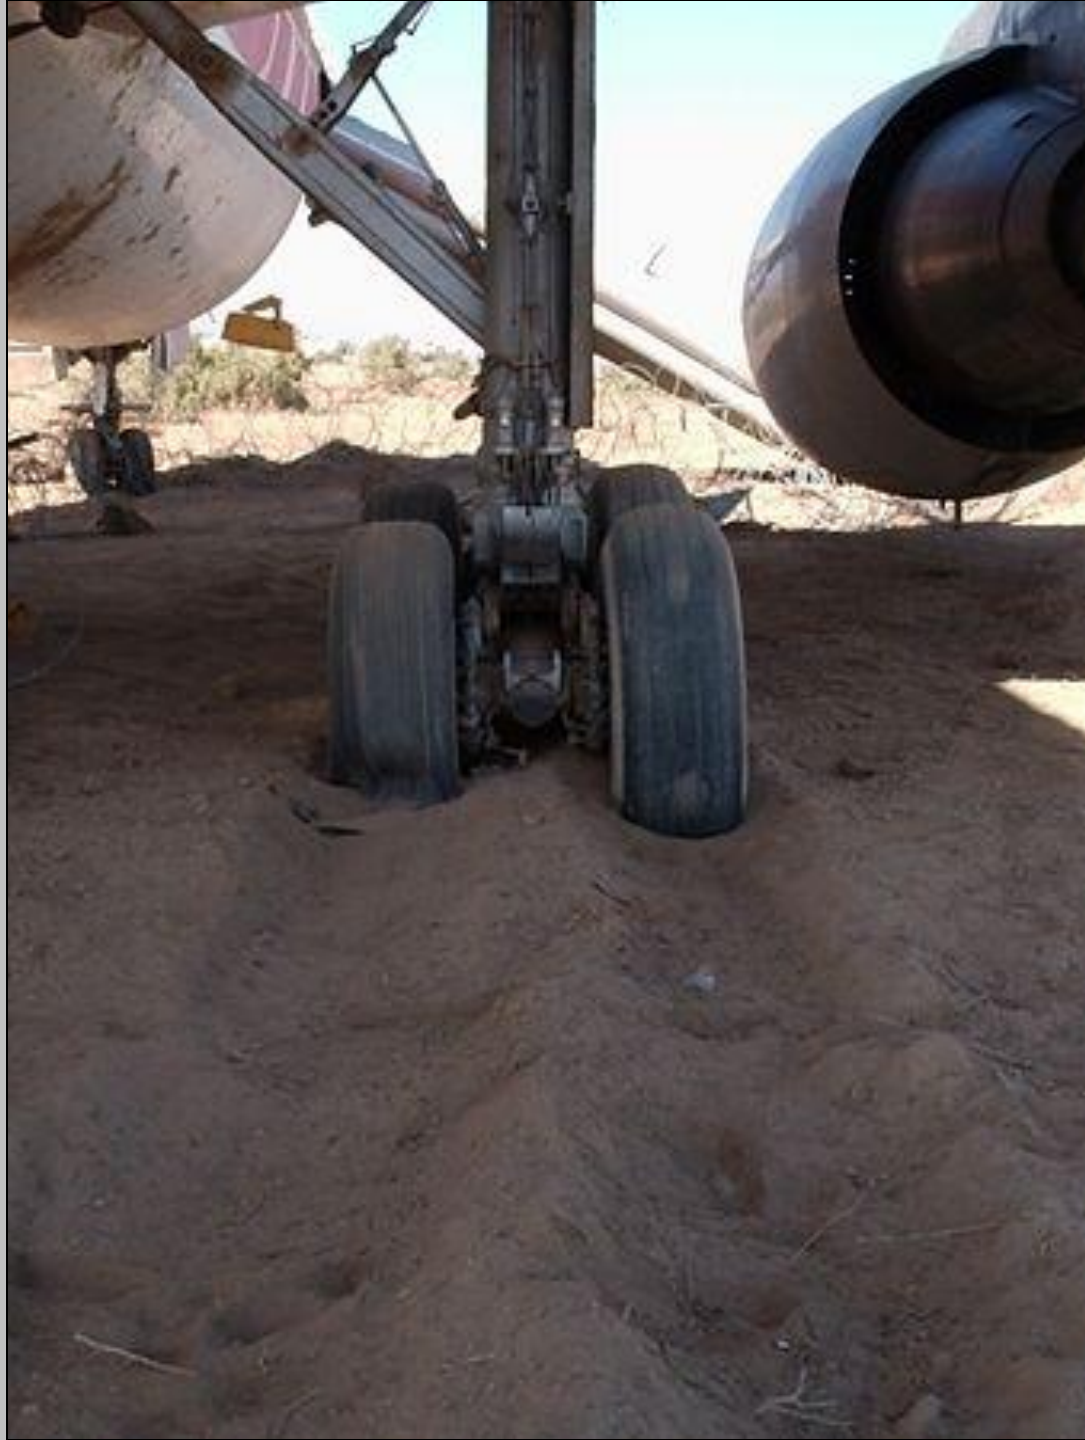
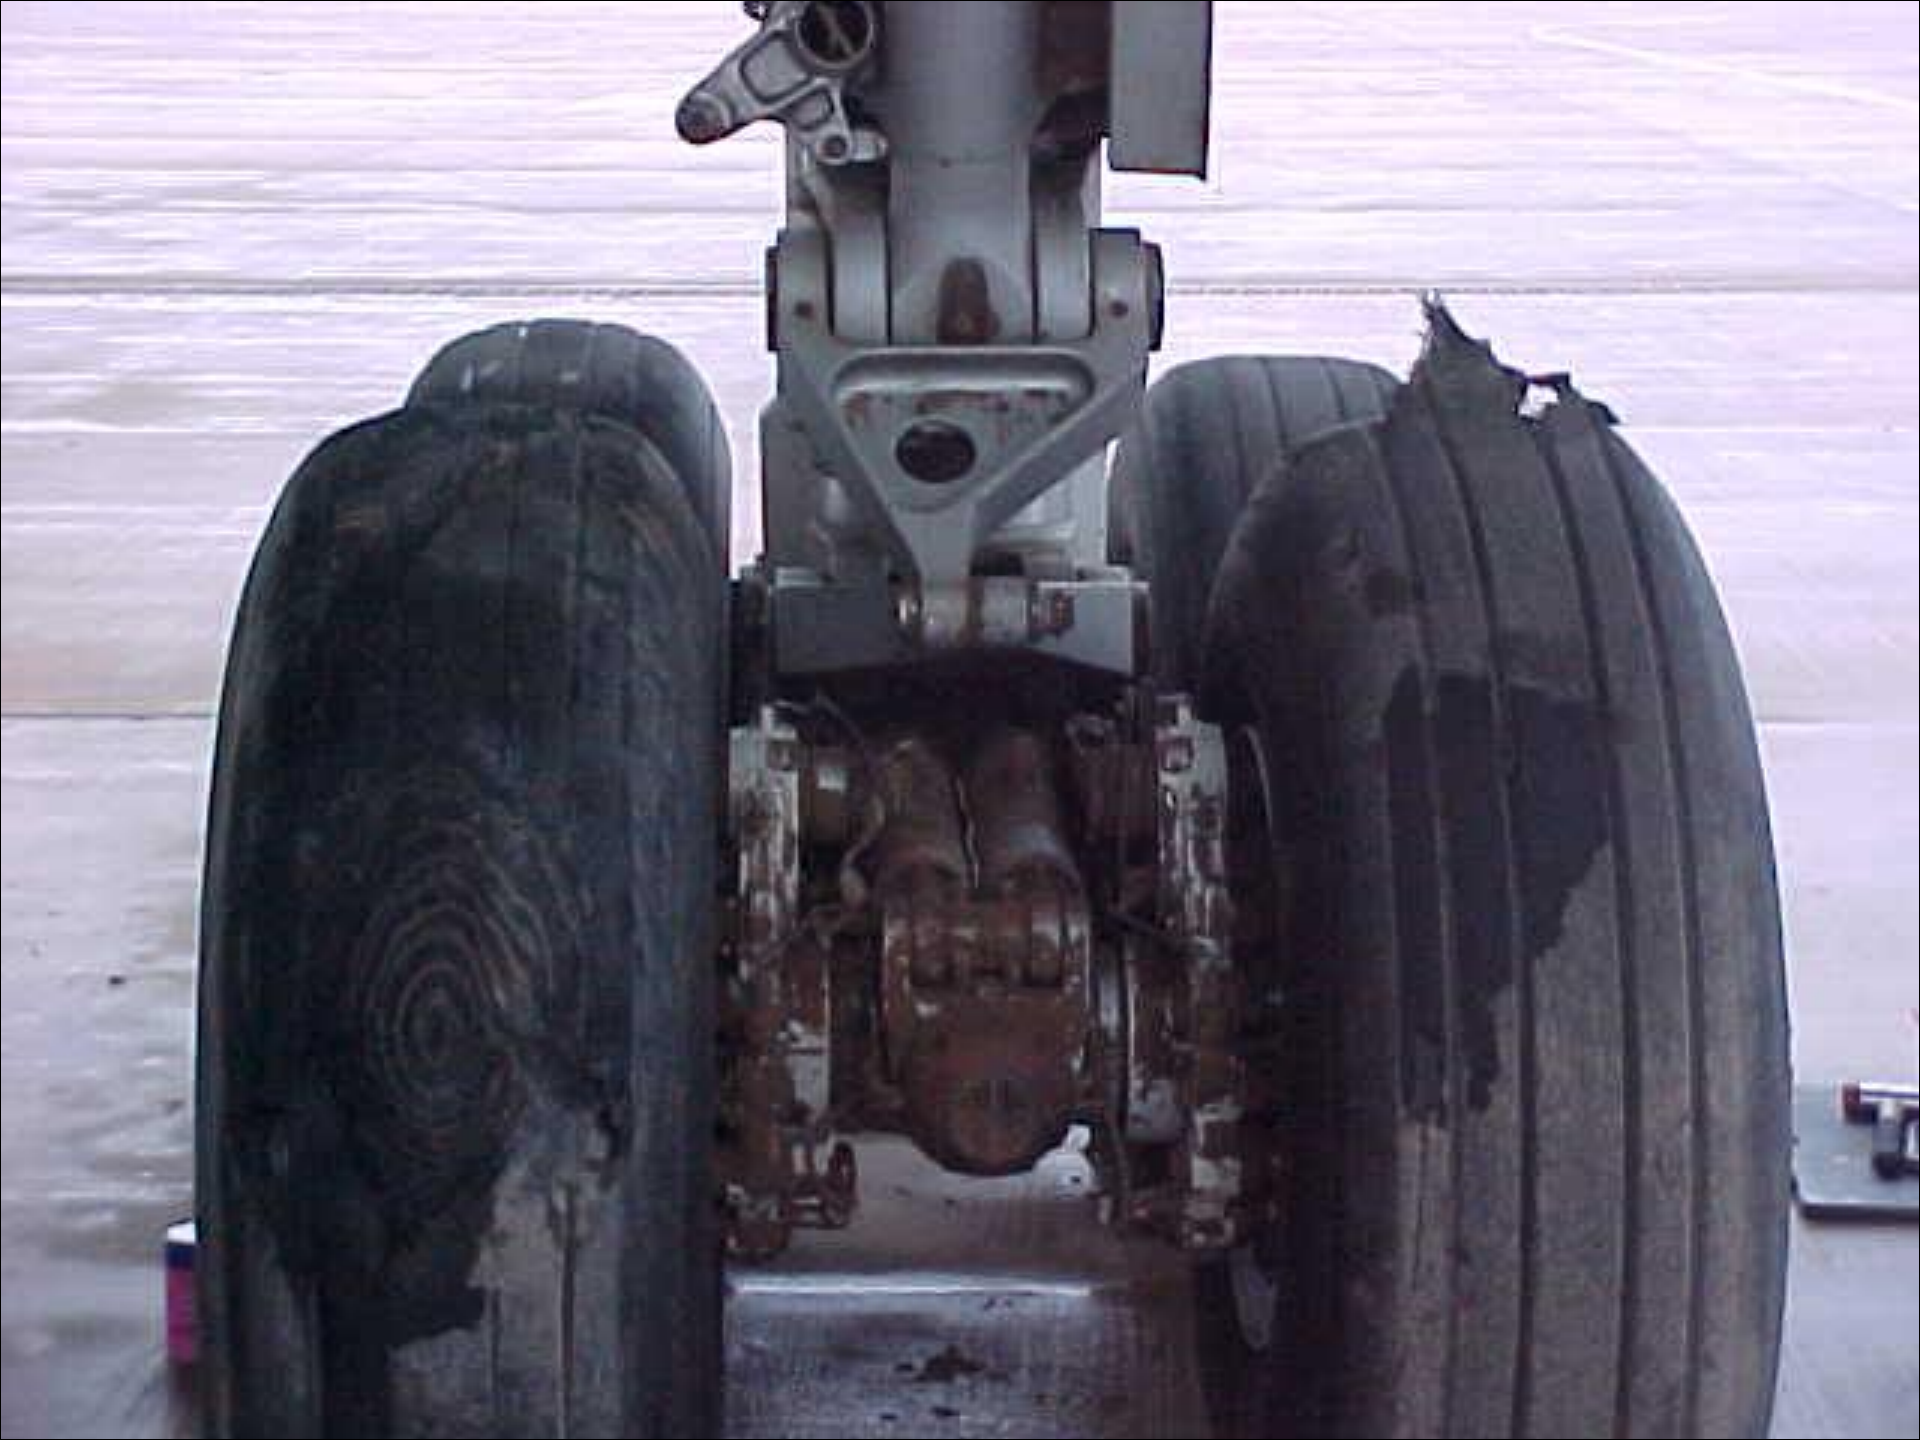
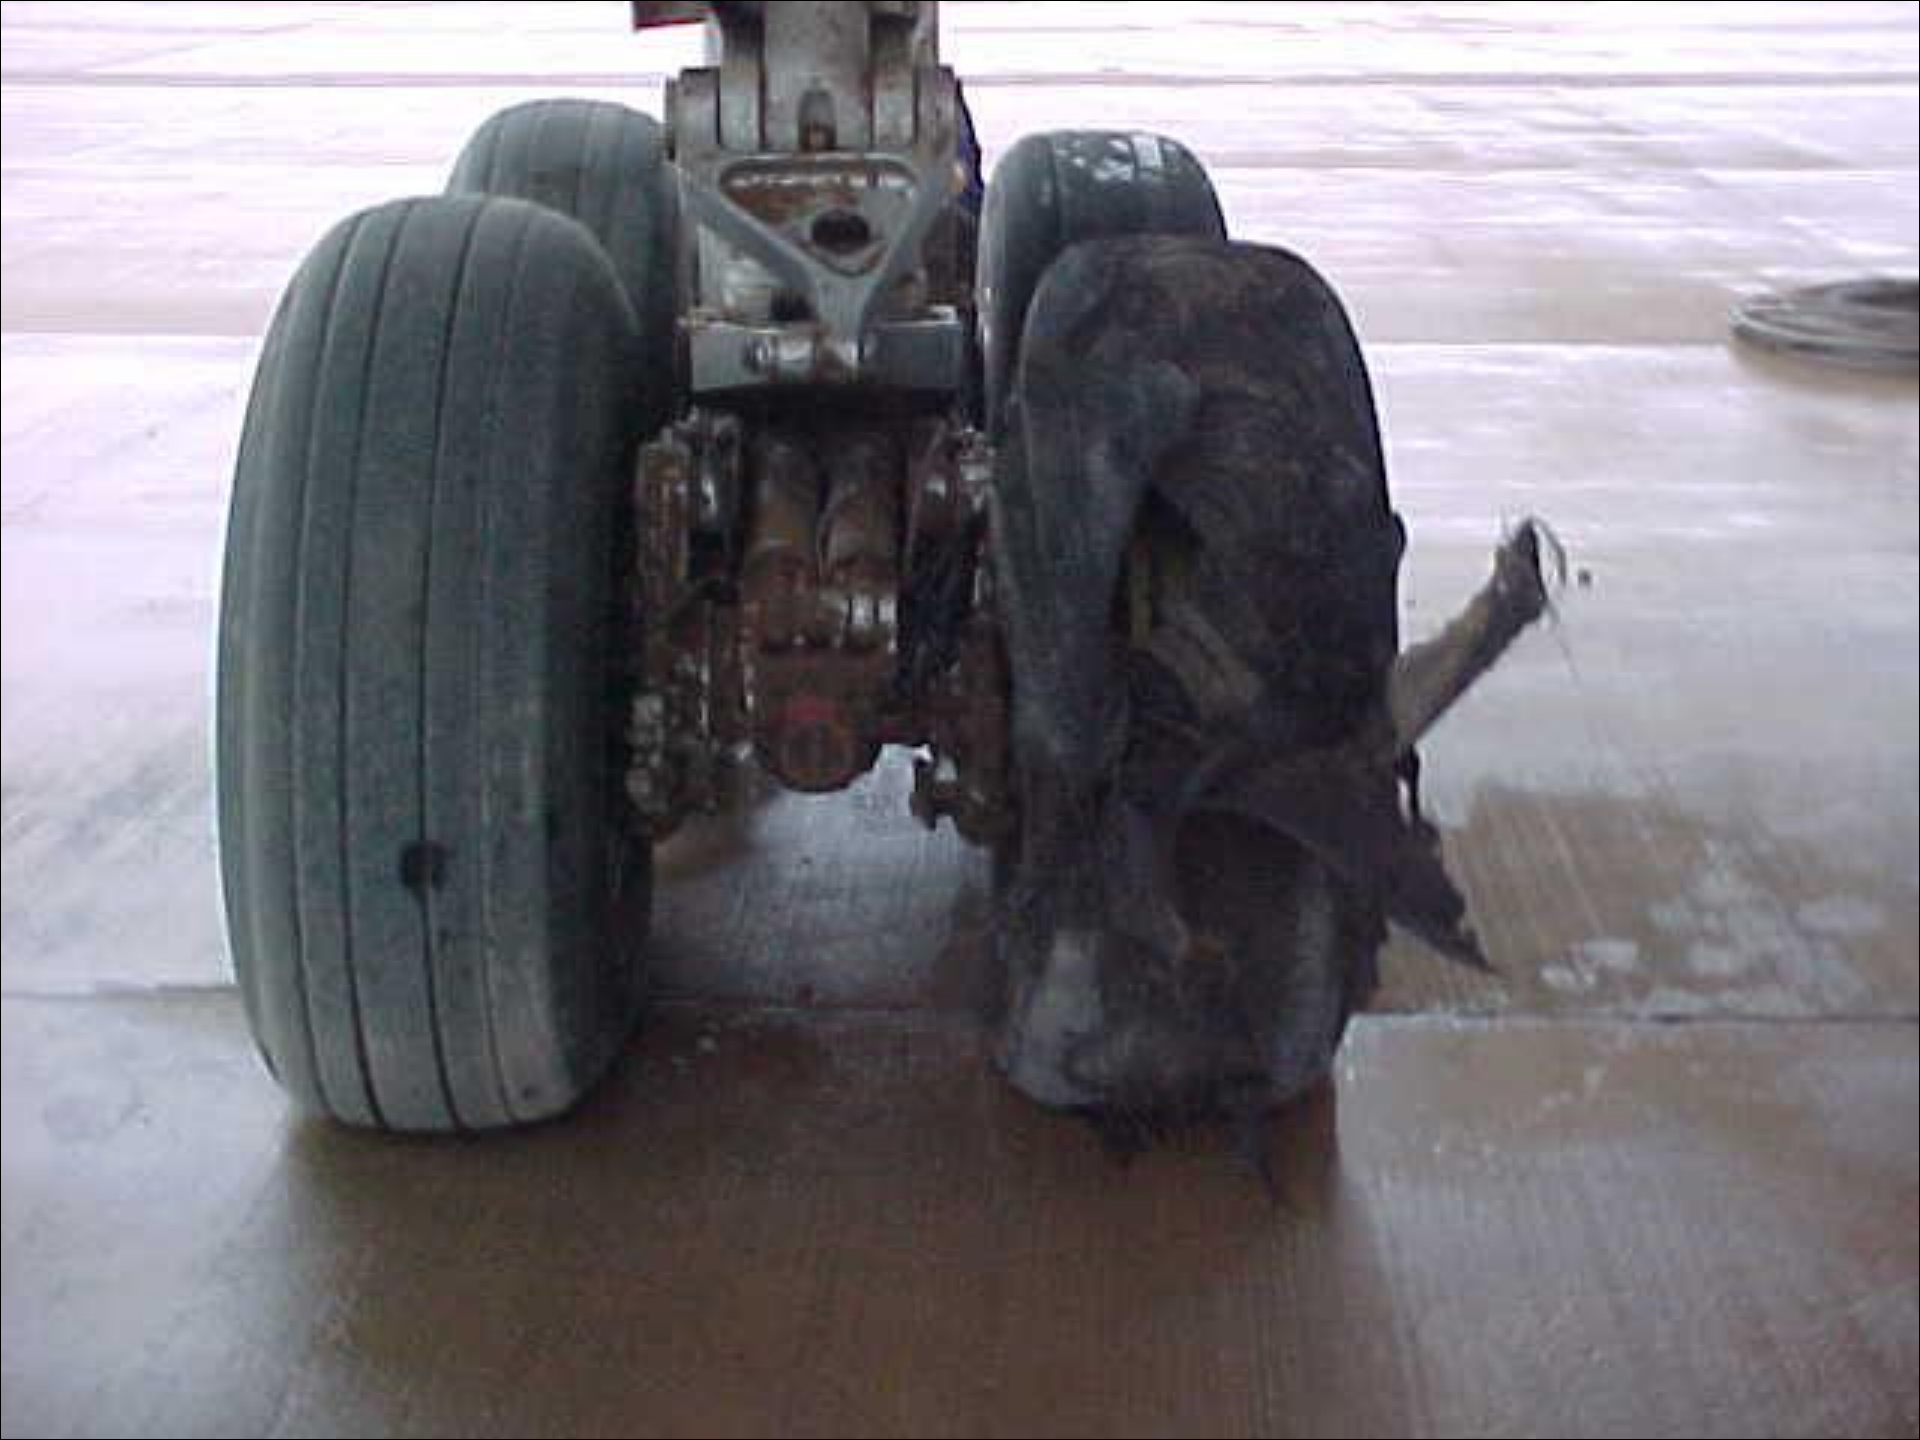
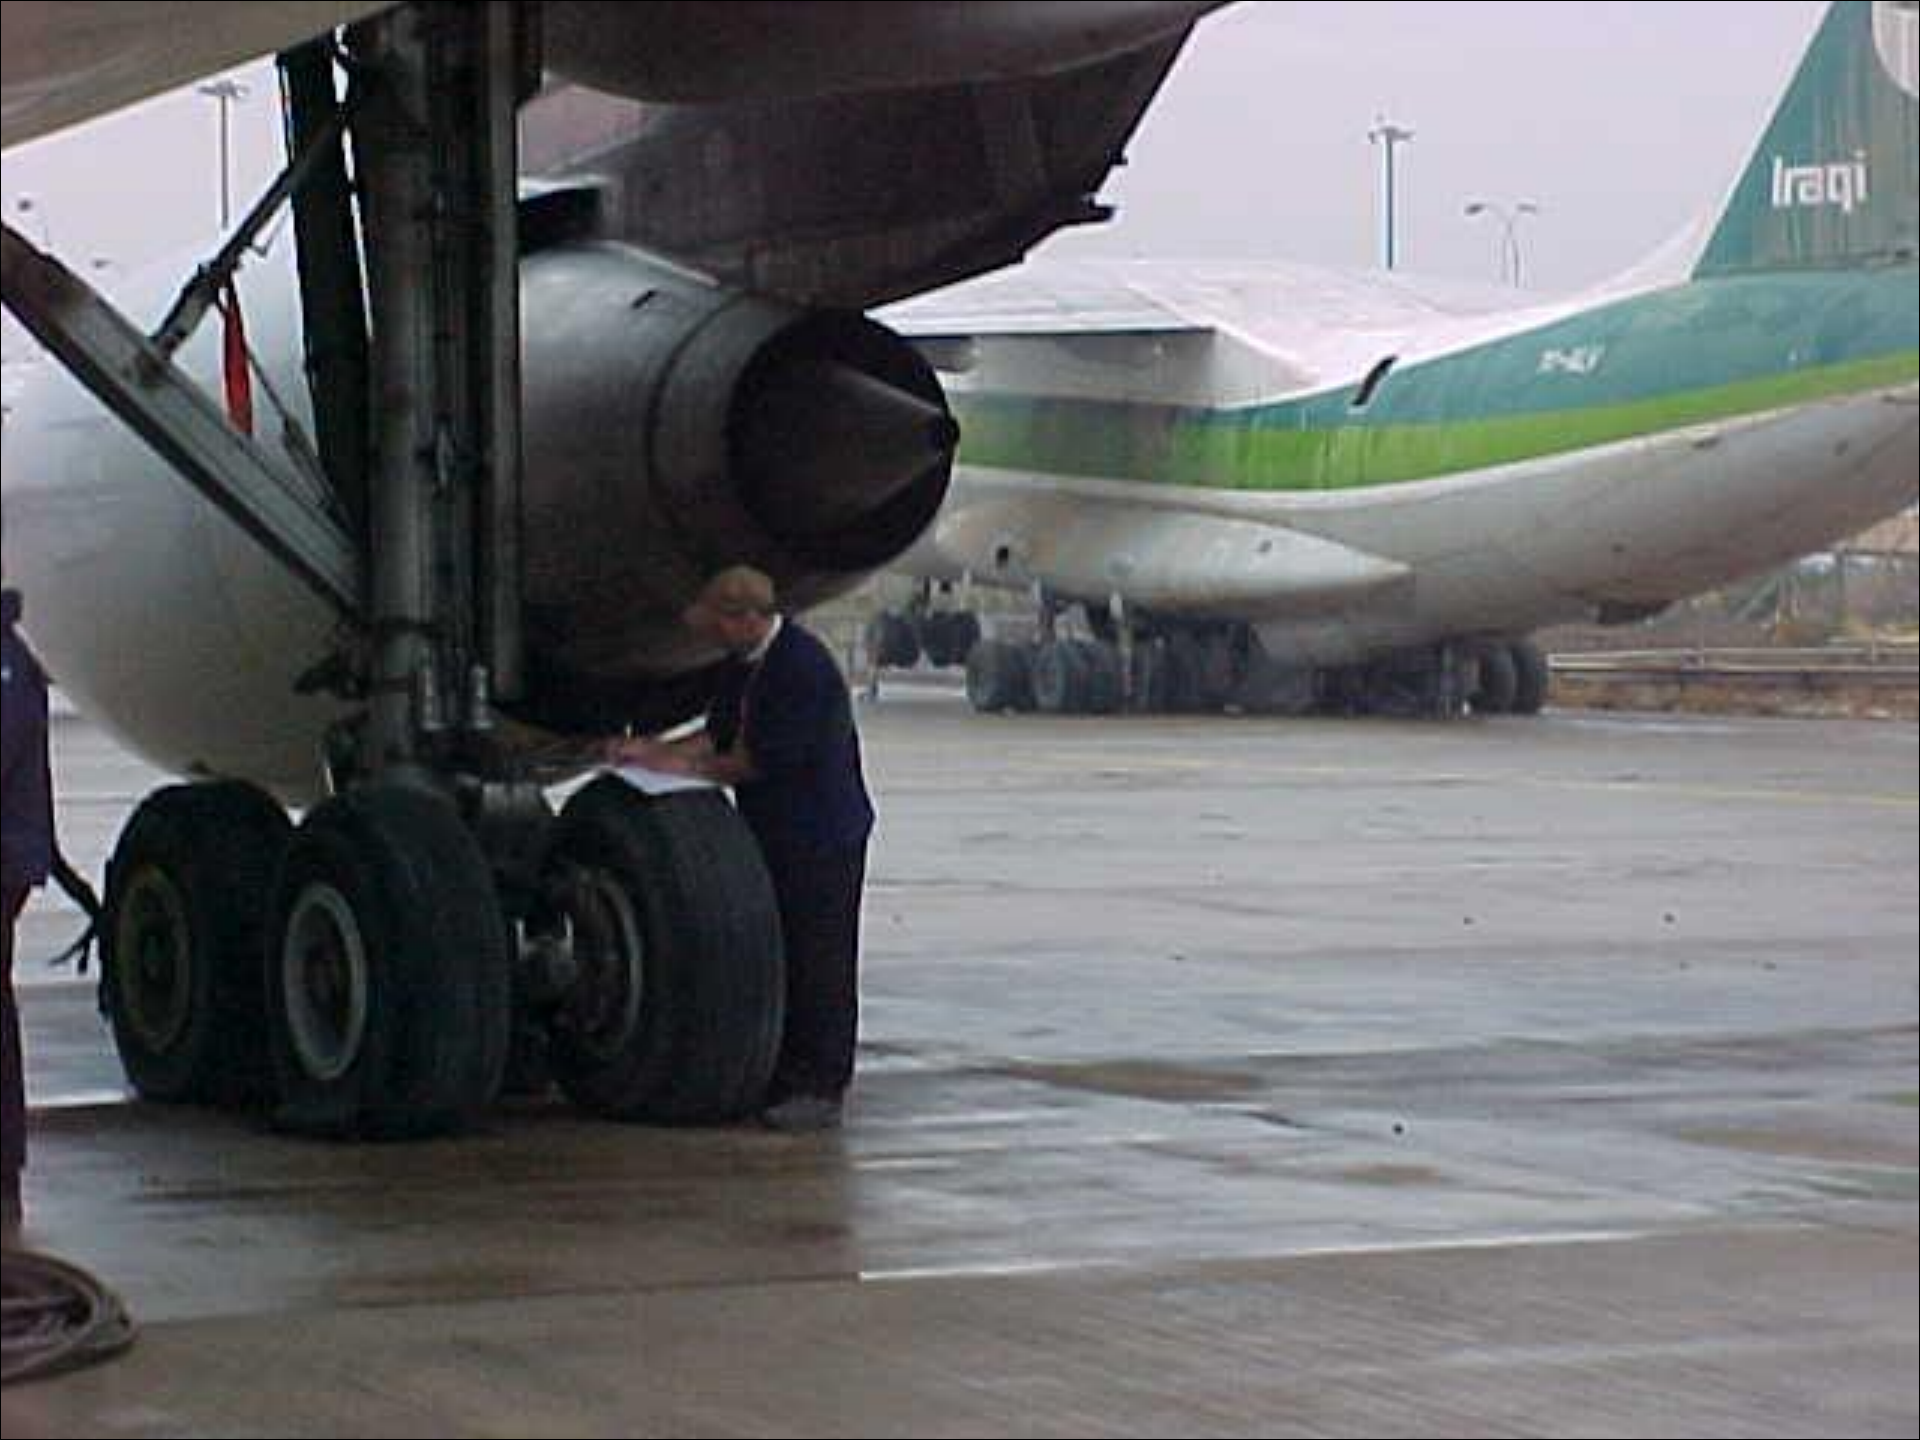
The No 8 axle appears to be cracked as the wheel sits at an odd angle. The bulk of the damage is the LH wing. About 3 metres of rear spar is missing in front of the outboard flap, the wing has bulged upwards and downwards where the initial explosion appears to have occurred, one O/B flap track is hanging in the breeze and one has a small piece of flap still attached, the rest of the flap is nonexistent. The pics show the huge crack that has occurred to the rear spar inboard of where the spar has burnt away, possibly from loads on the wing during the landing process.
