## **Testimony to an A300B4 and his crew**

DHL International Aviation,  
Bahrain.

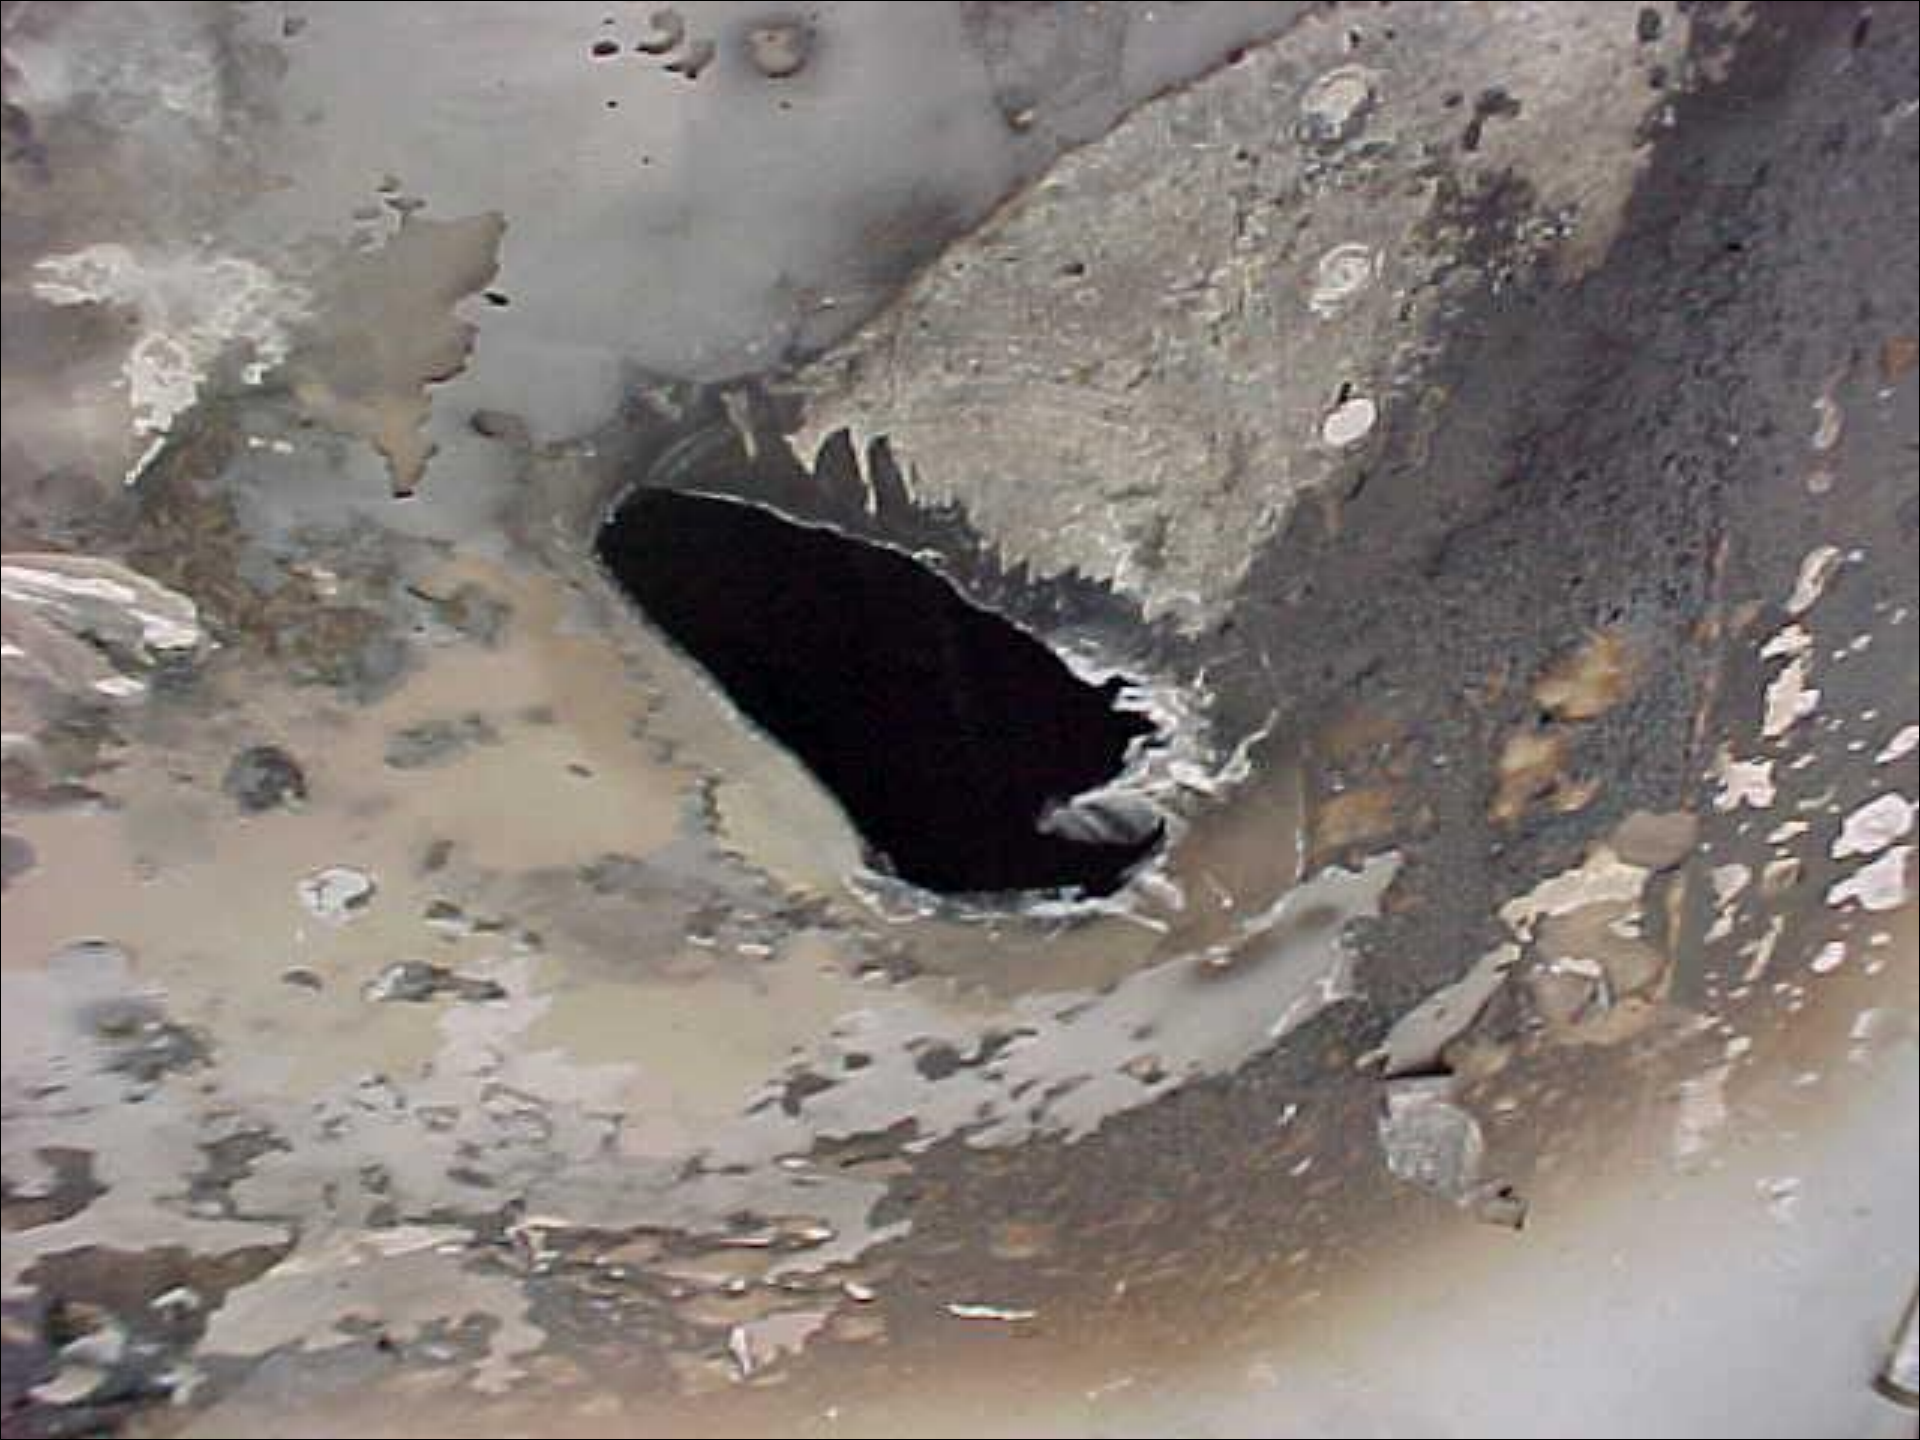
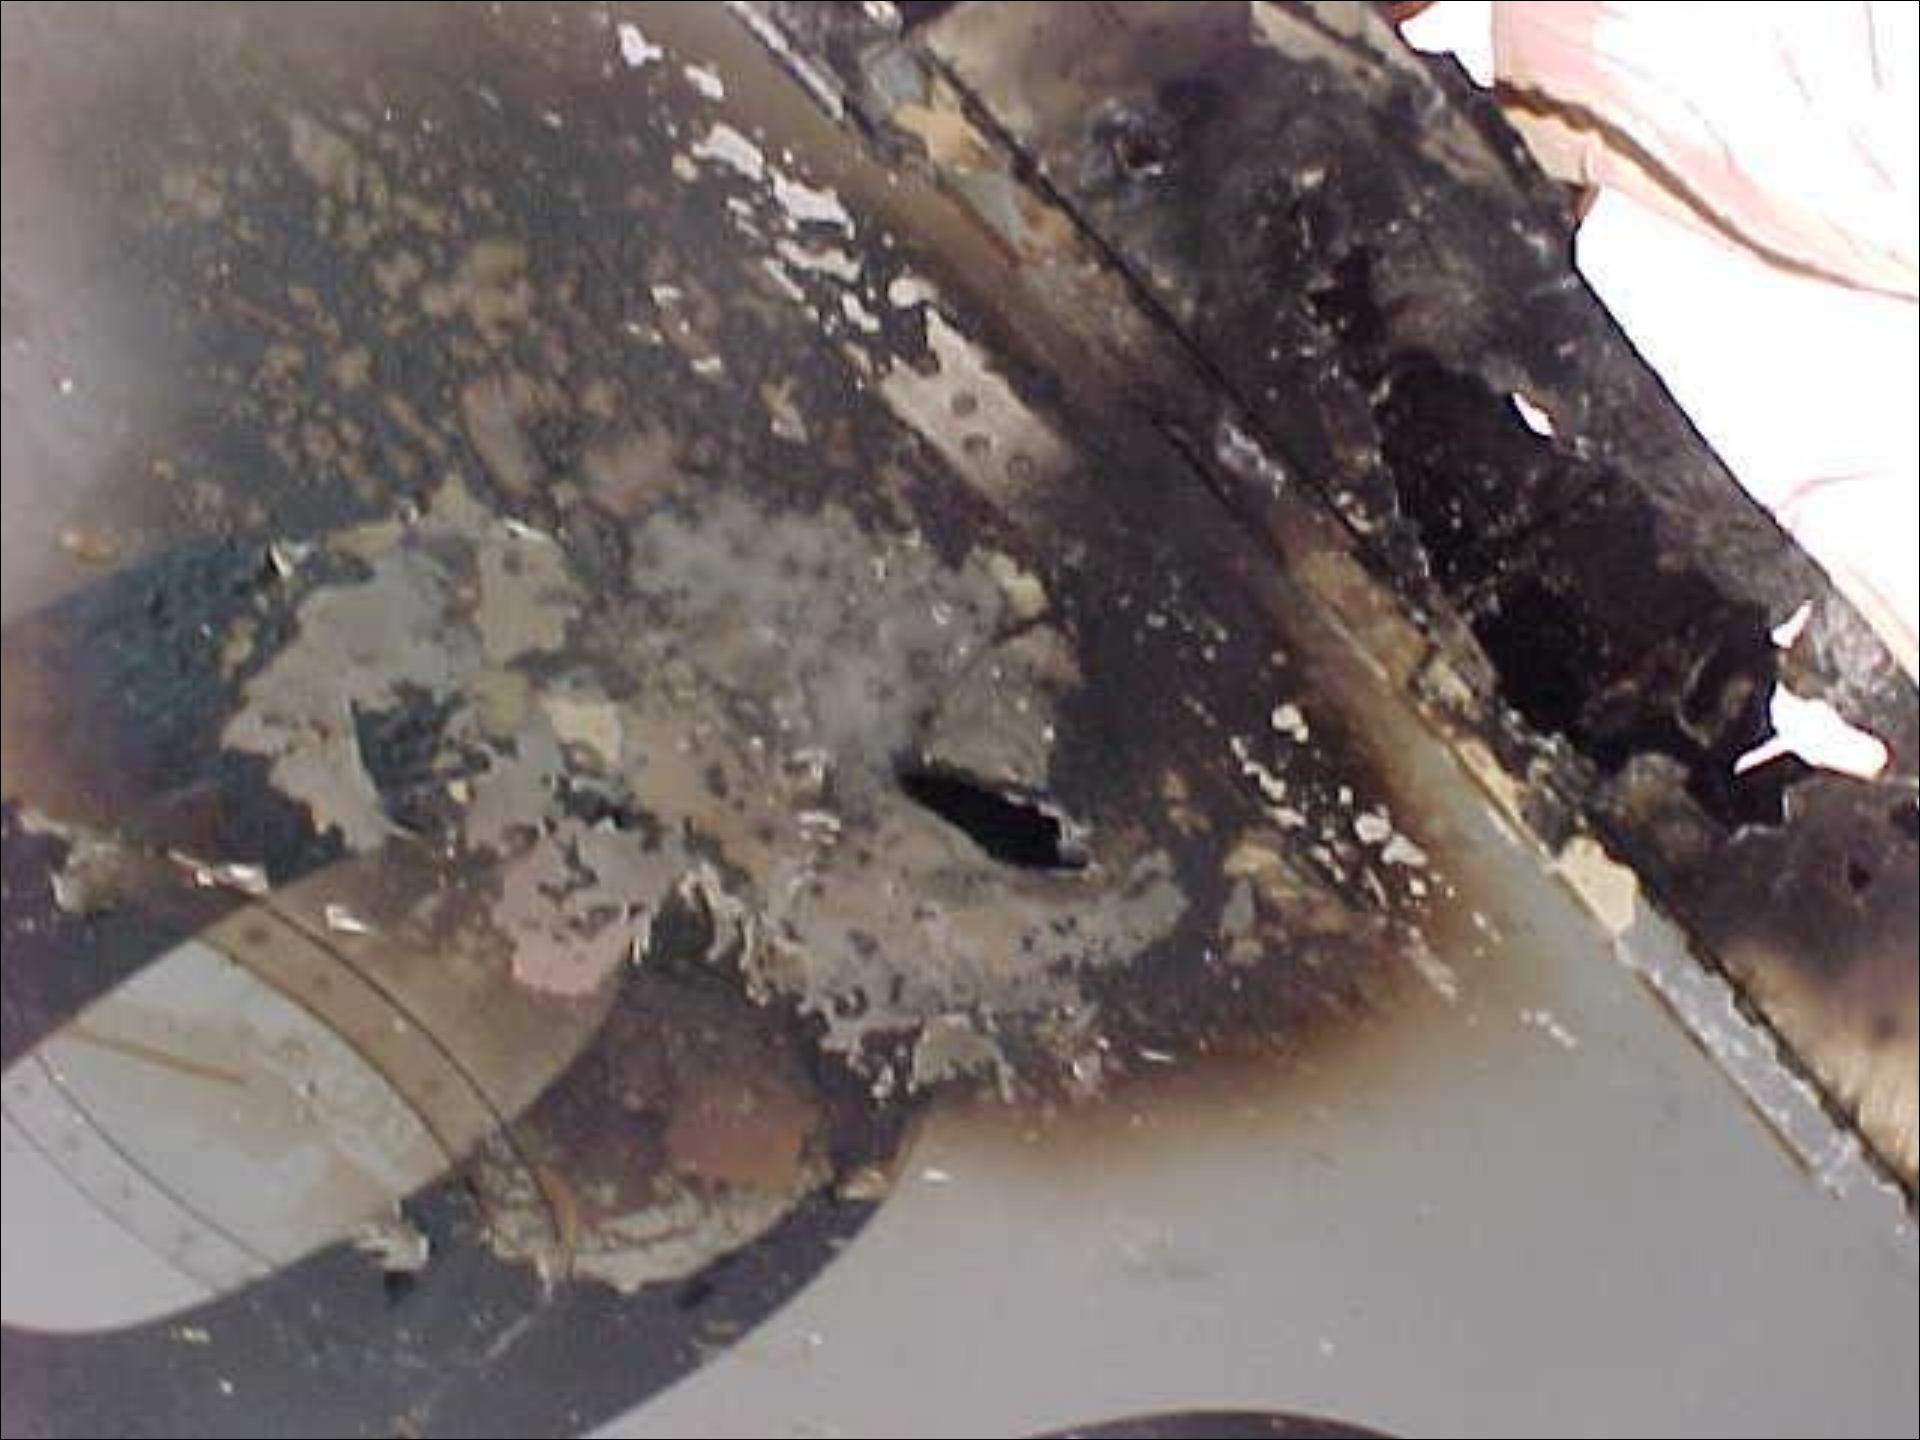
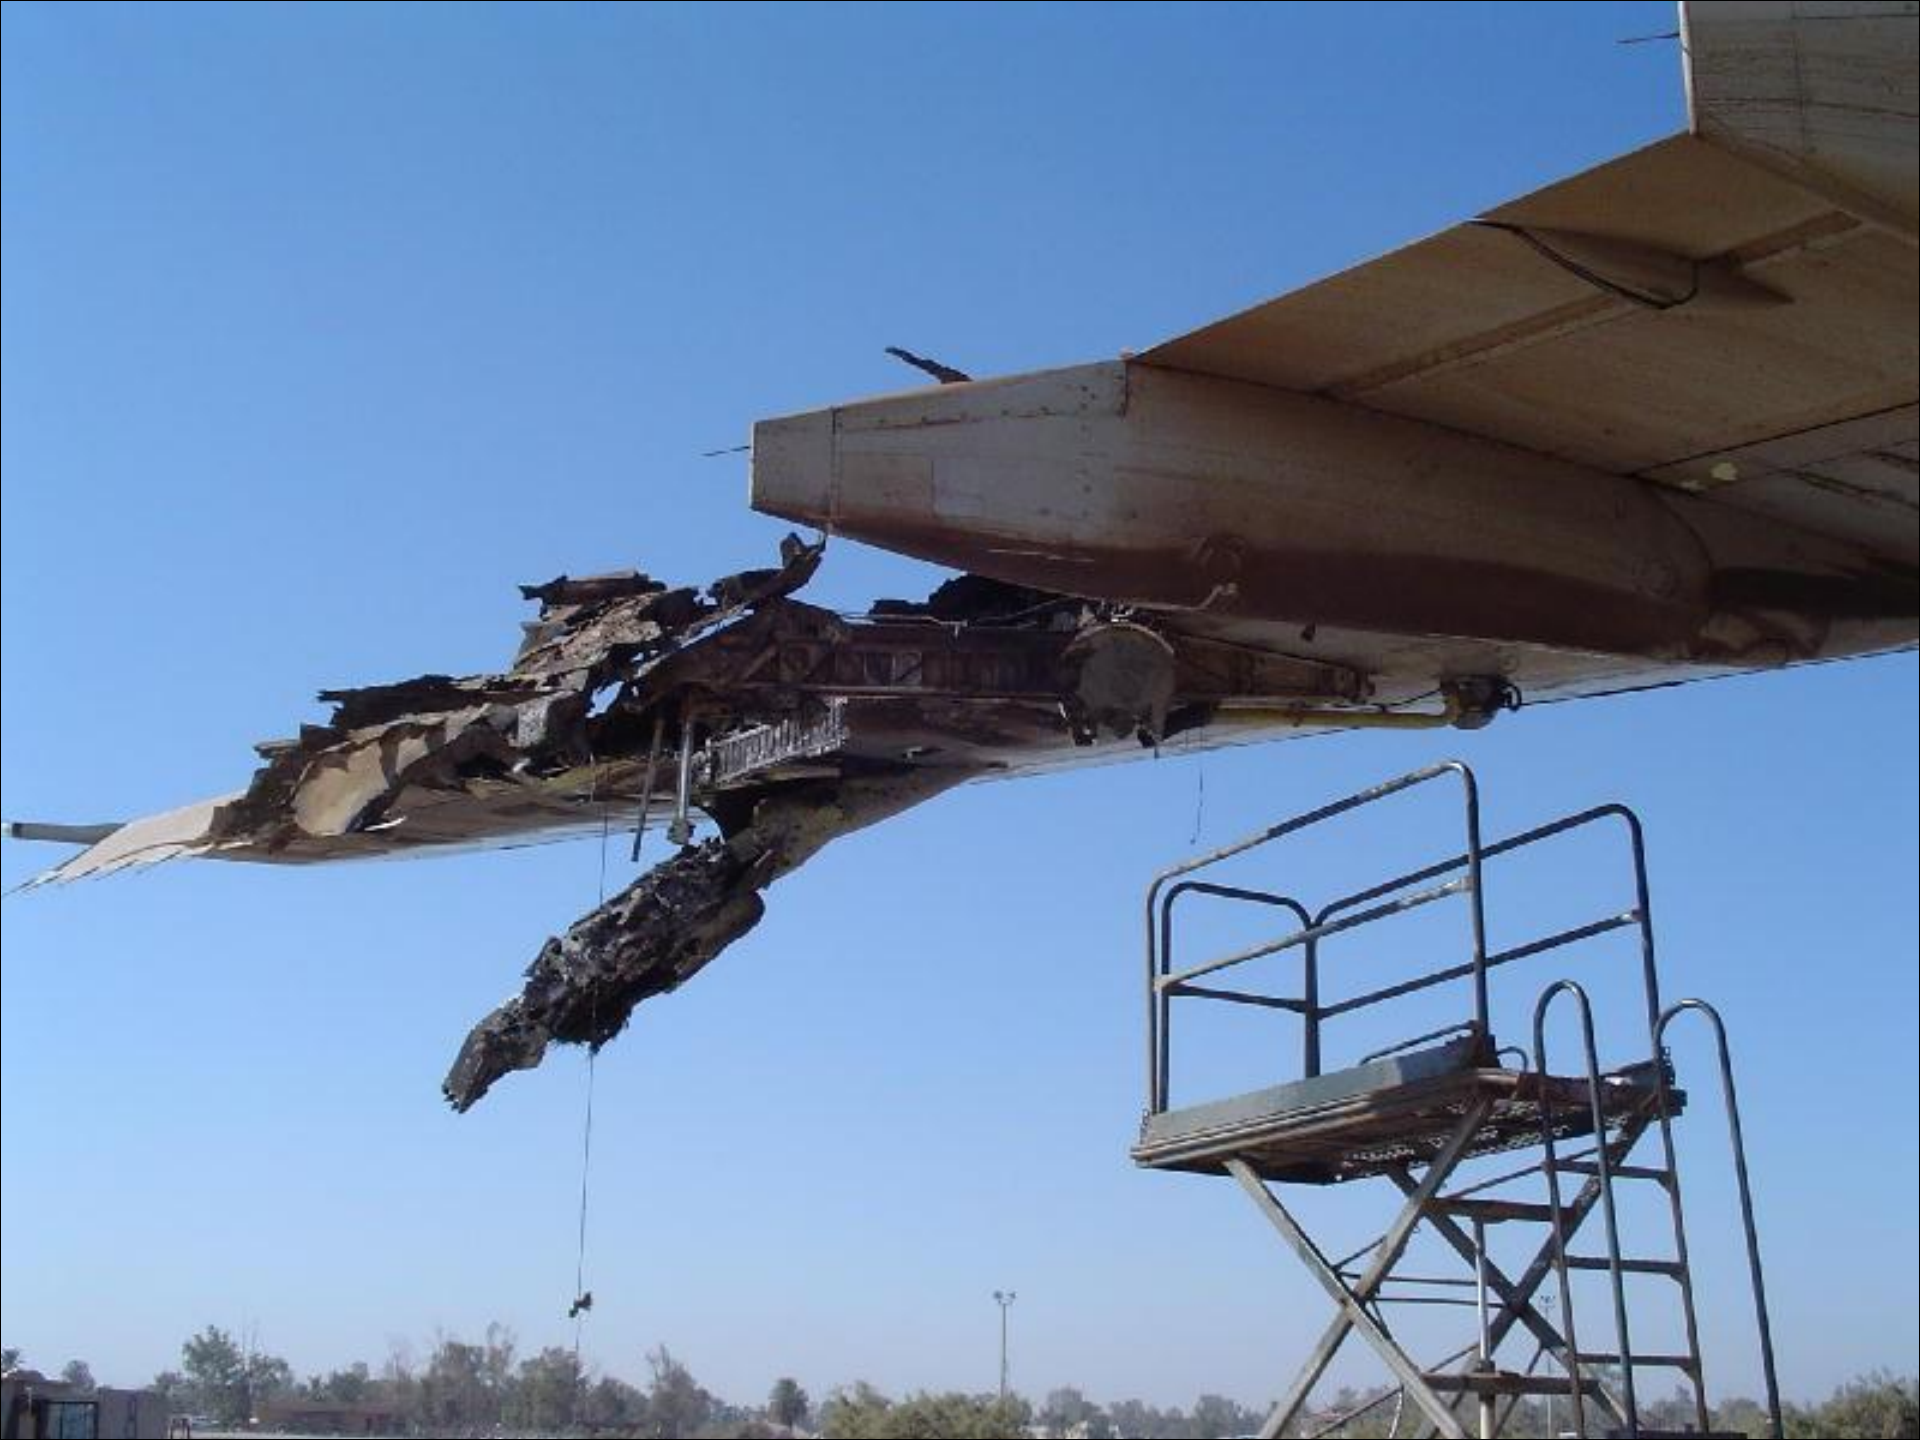
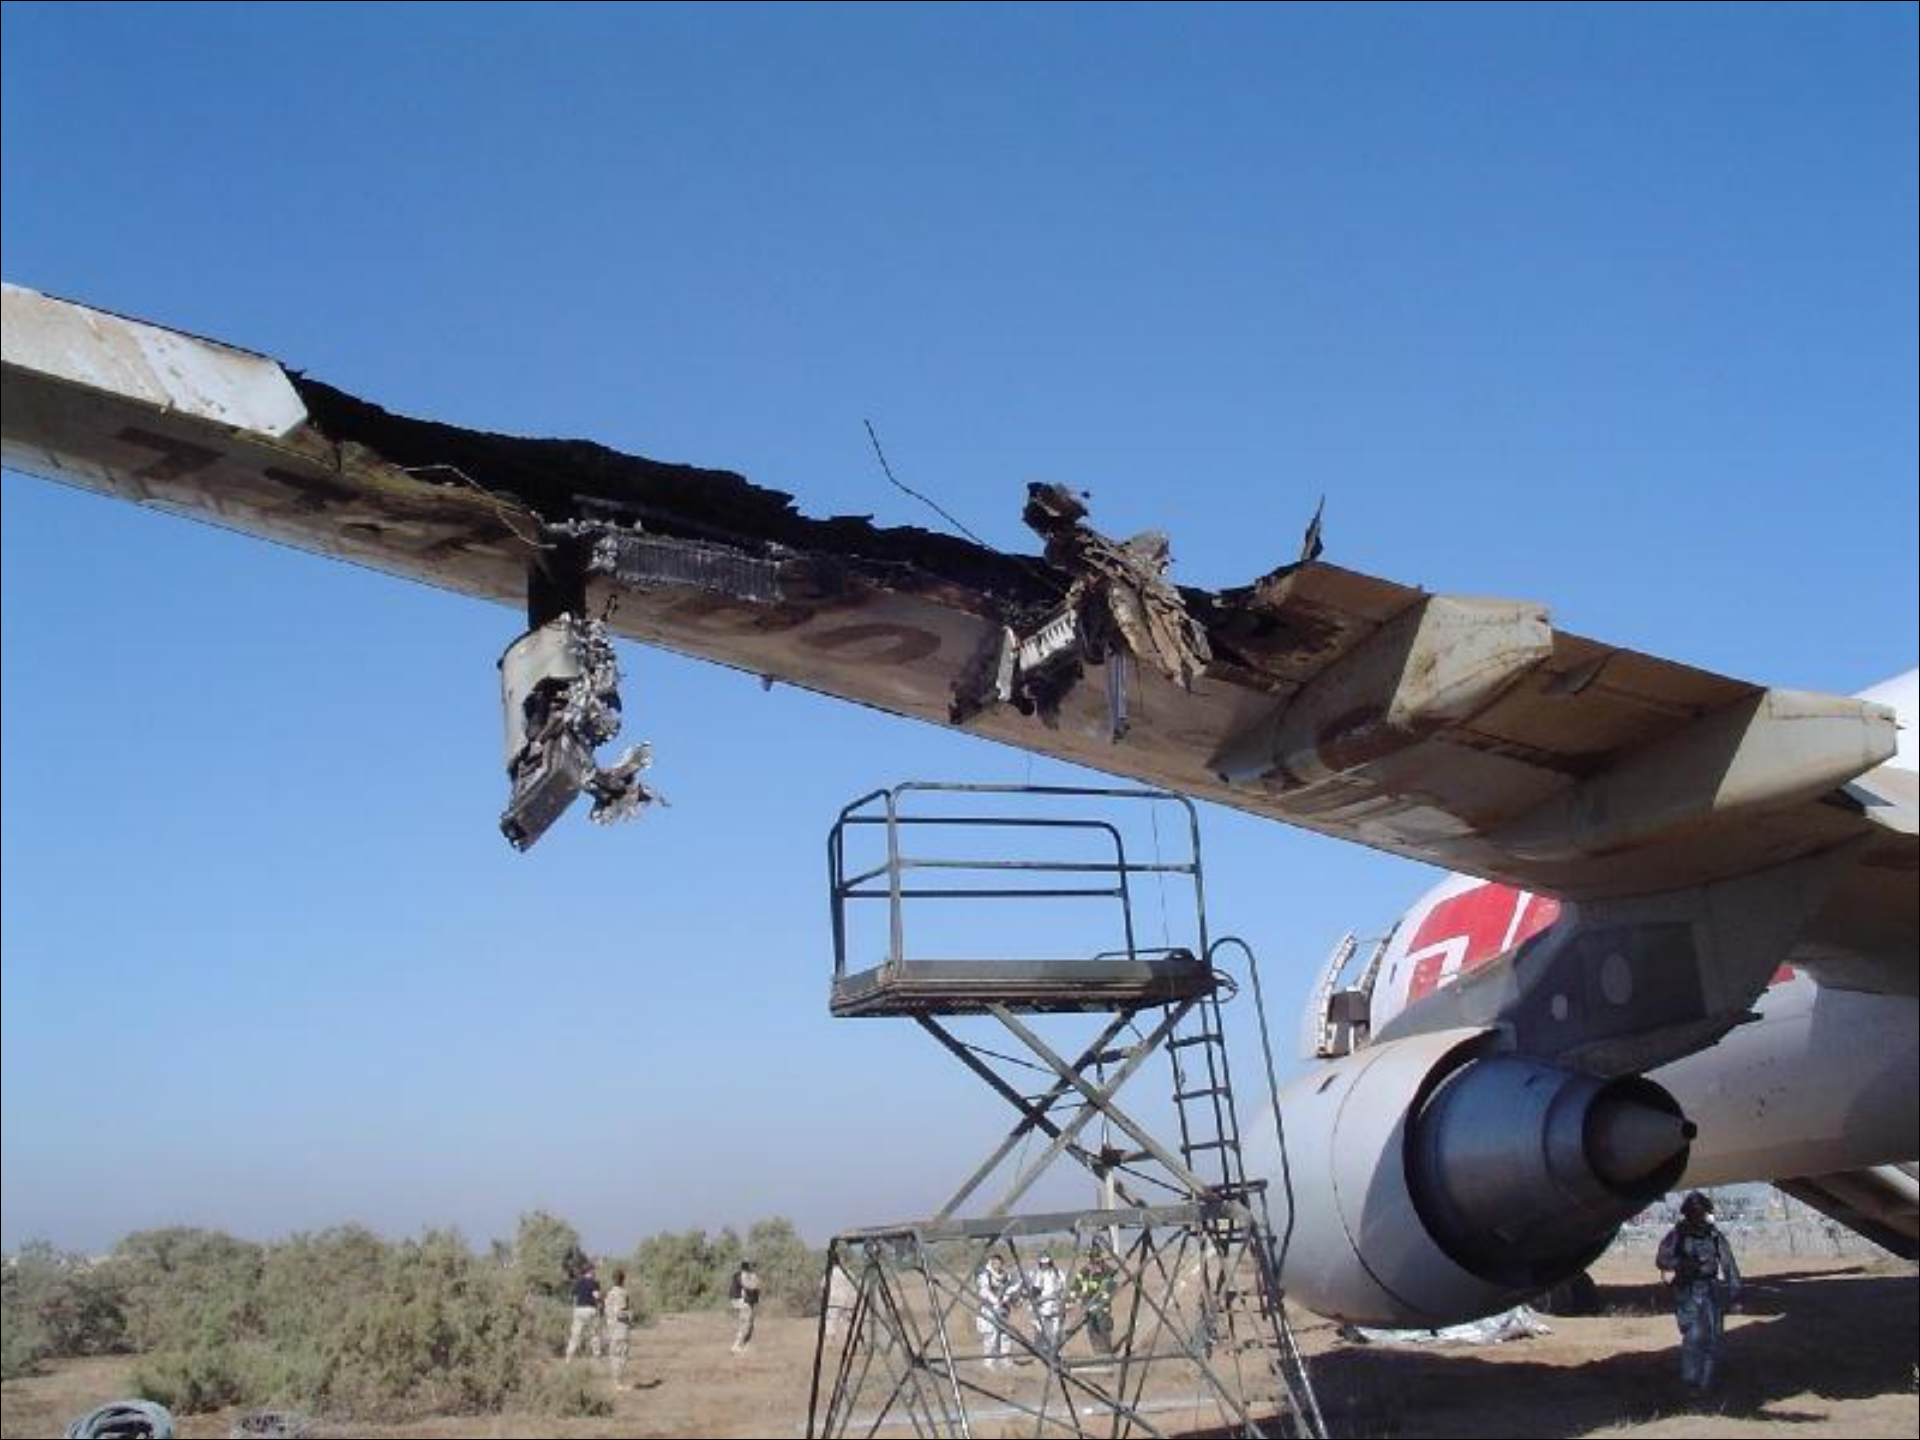
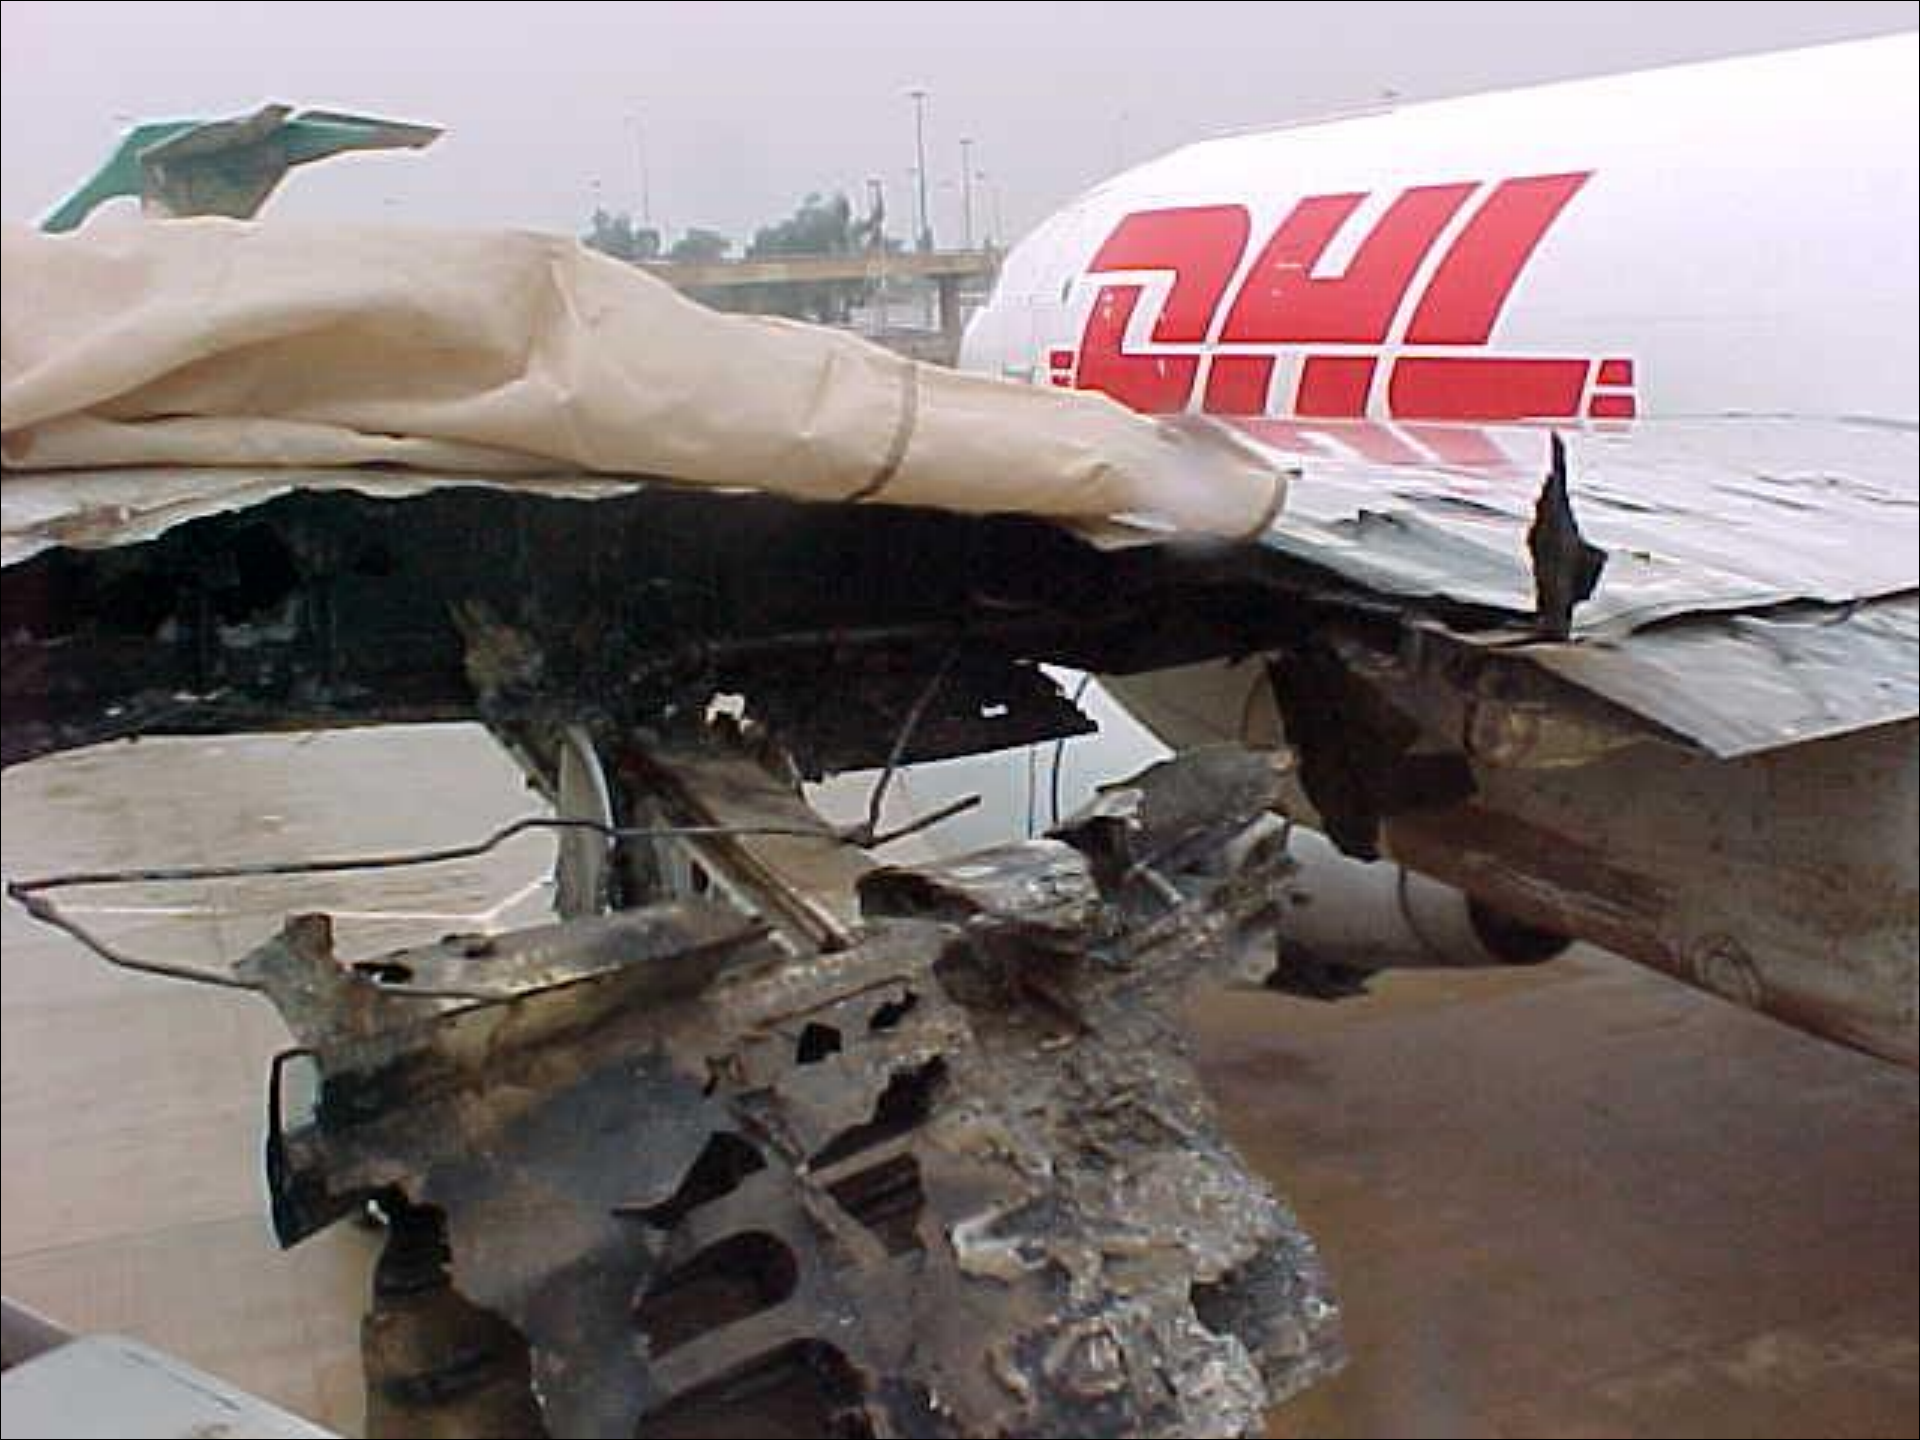
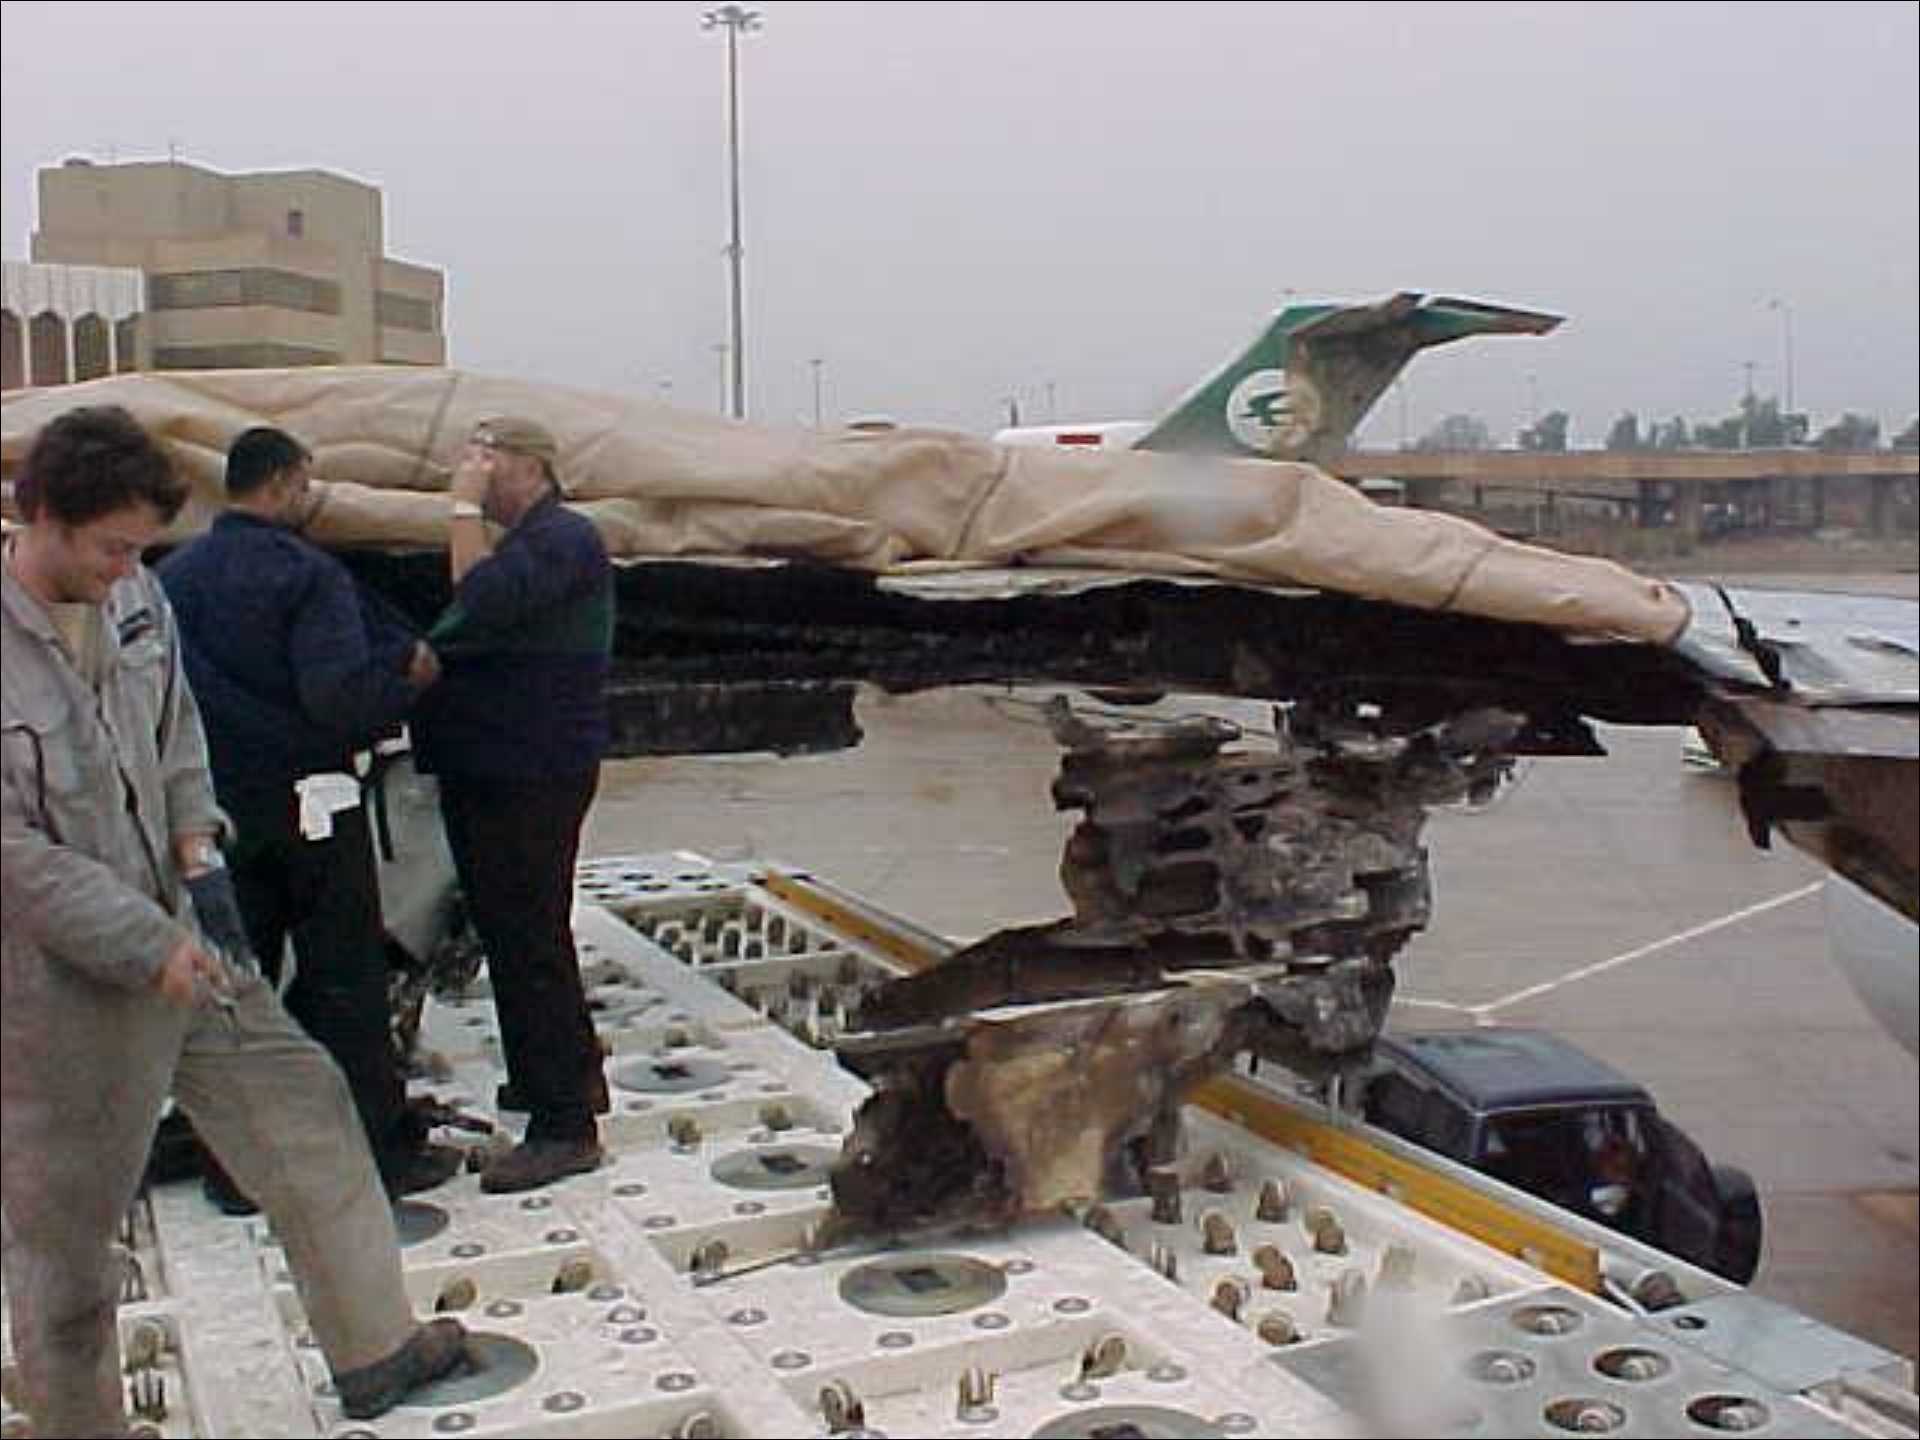
The front spar appears to be intact. The point of entry pics show where a projectile entered Tank 1A, which was full of fuel, and, after it ignited, proceeded to burn away at the spar.

The fuel tank ribs in the area directly in front of the O/B flap are burnt almost 50% through.
